COMPLAINT

Boost Valve & Sleeve Kit

84754-30K

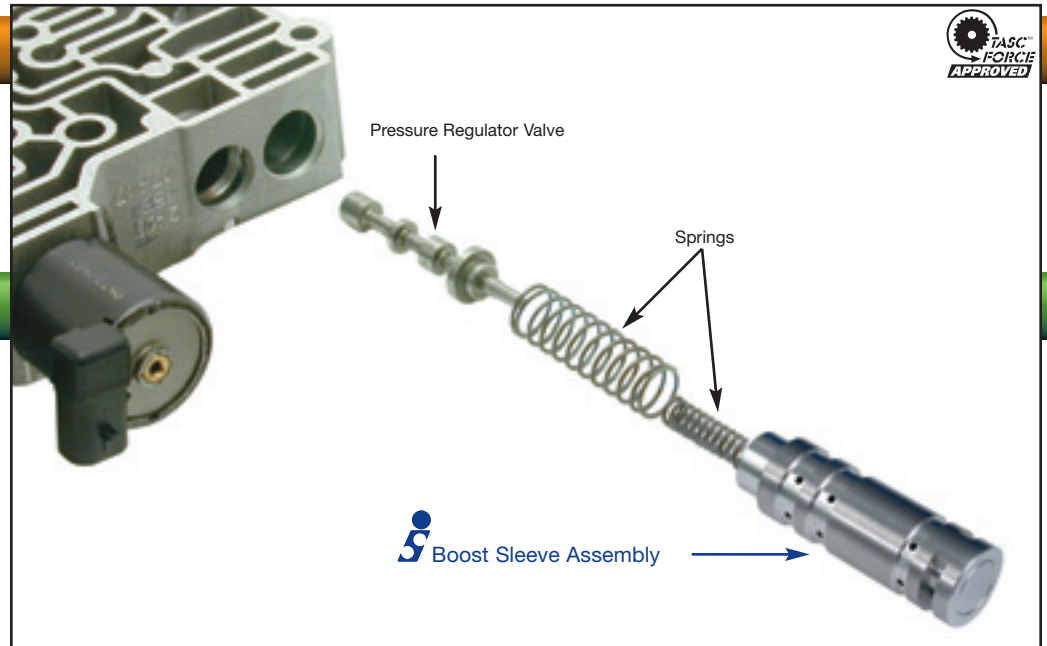
1 Boost Sleeve Assembly
Note: U.S. Patent No. 6,832,632

Bore wear near the small valve causes harsh or delayed reverse depending on the location and severity of the leak, and the temperature wear near the end plug causes soft shift quality and low line rise.

The replacement boost sleeve delivers oil 360° around the valve, reducing side load. Also the surface contact of the spools is greater, which improves durability and reduces oil loss.
