## Oversized 1-2 (Forward) or Reverse Servo Boost Valve

### 84754-40K

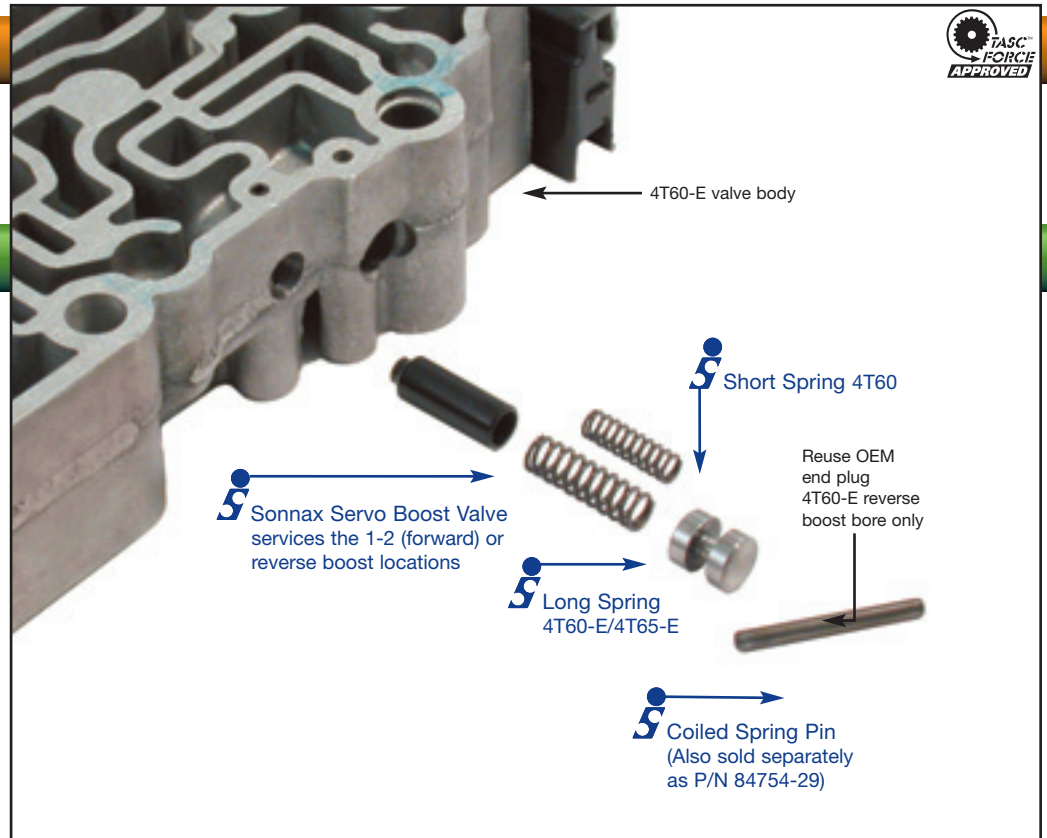
These complaints may be caused by the continuous reciprocation of the 1-2 (forward) and reverse servo boost valves wearing the valve body bores.

The continuous stroking of the 1-2 (forward) and reverse servo boost valves wear away at the valve bore, creating excess clearance and reduced apply pressures. This can lead to 1-2 band slippage, delayed engagements, 1-2 shift flares, and decreased reverse pressure. Sonnax has developed an oversized valve **84754-40K** that will restore the hydraulic integrity and more than doubles the valve-to-bore contact area to prevent leakage.

This oversized, hard-coat anodized aluminum valve restores hydraulic integrity, and has increased valve-to-bore contact to prevent leakage. This valve requires the use of a Sonnax reaming tool kit.
