Case Dowel Pins

85000-01

Sonnax Part Summary

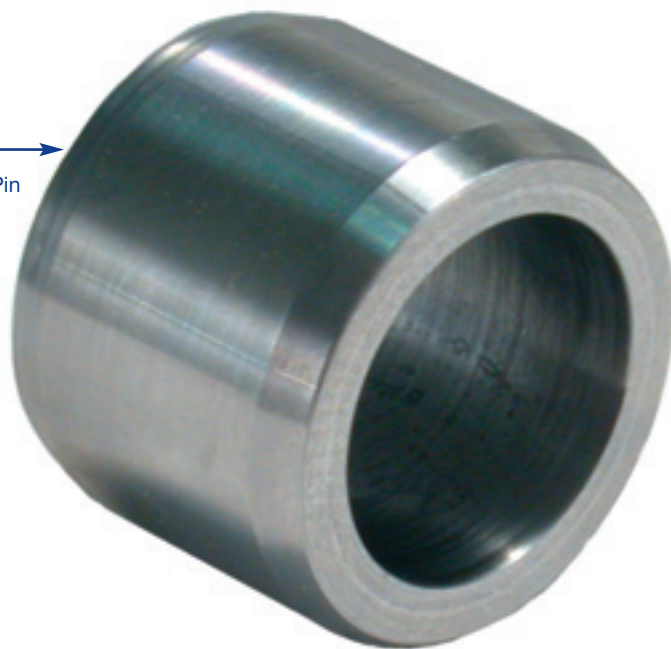
Case Dowel Pin

Misalignment or damage to the transmission case

The thin wall construction of the OEM pins is not durable enough.

A common problem with OEM case dowel pins for the ZF5HP30 is weak construction, which results in misalignment or damage to the transmission case. The Sonnax dowel pin **85000-01** is a more durable guide pin between the engine block and transmission case, preventing the misalignment that can occur with the OEM guide pins.

Replace with these case dowel pins that have a thicker wall.
