Pump Bushings

Sonnax Part Summary

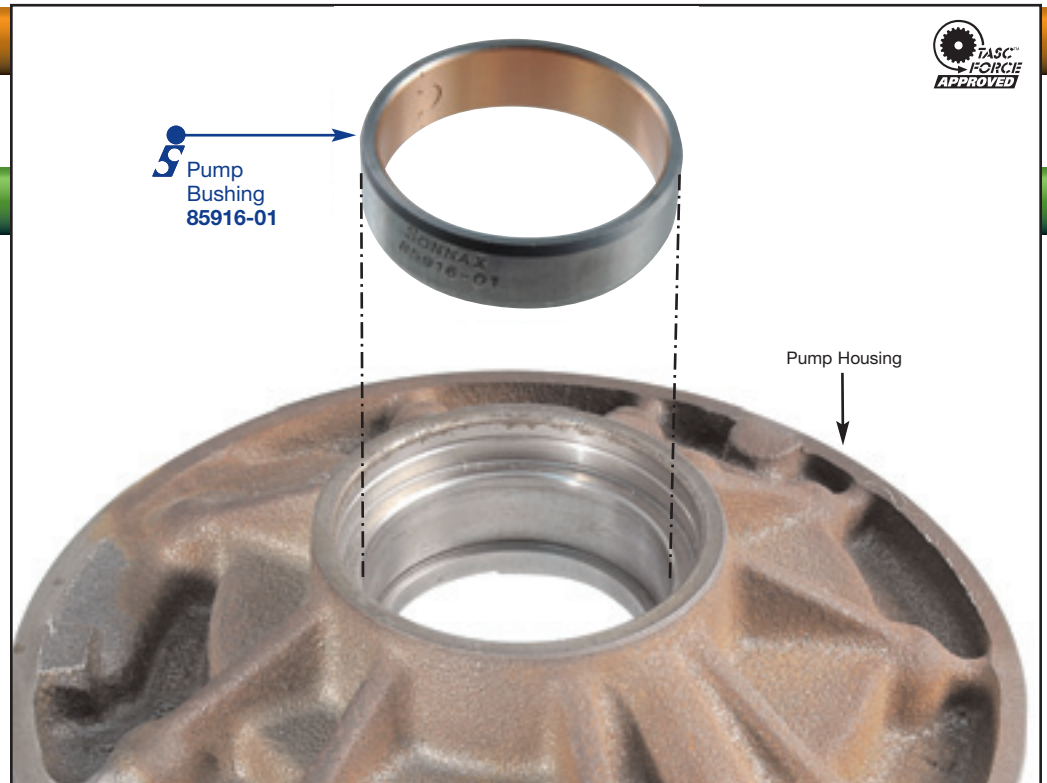
Pump leaks, bushing spins in housing

- Delayed engagements due to drainback • Loss of pump core

Excessive bushing and shaft clearance caused by normal wear.

The Sonnax bushing allows salvage of the pump by oversizing the housing bore for installation of a new, tightly toleranced bushing.

Note: Bushings are oversized precision bushings for damaged pump housings. The pump-housing-bushing-bore ID will require machining. This ID will have to be machined to $\text{Ø}1.9992'' \pm .0005''$ ($\text{Ø}50.780\text{mm} \pm 0.013\text{mm}$).
