## Poor throttle pressure control, very late or no upshift

## Throttle Control Valve & Plunger Sleeves

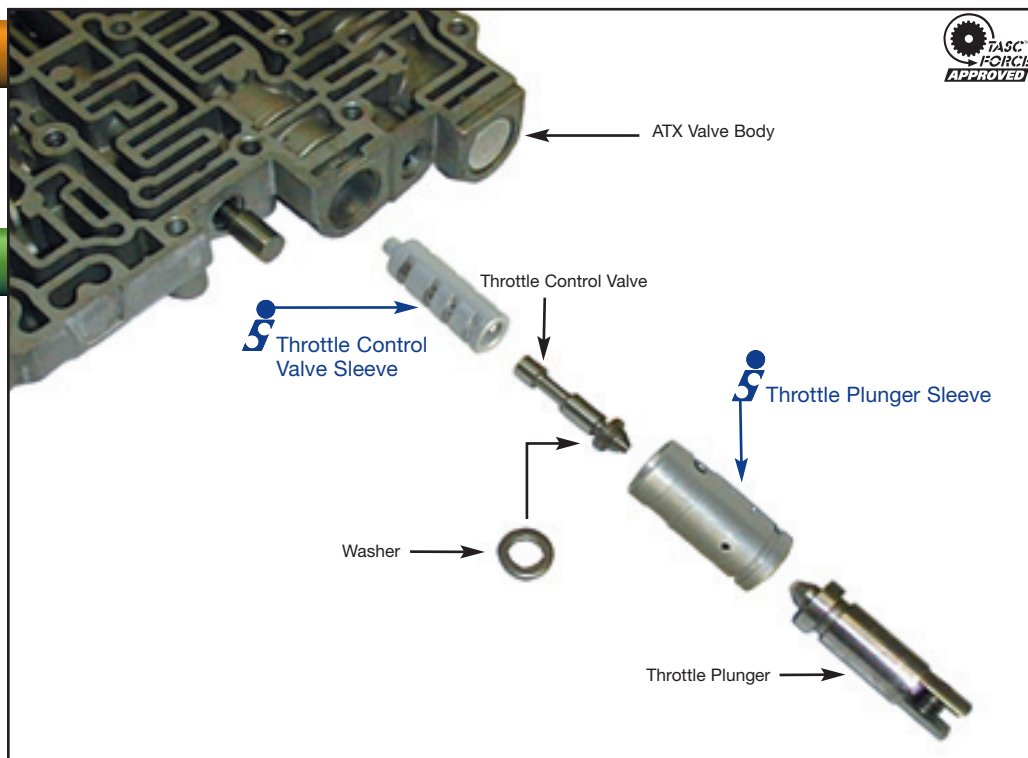
• Hydraulic bind on accelerator linkage • Sensitive shift timing • Low line pressure • No kickdown

Wear on the throttle control valve and/or throttle plunger sleeves from the steel valves can allow TV oil to exhaust.

The drop-in replacement throttle sleeves are manufactured from highly wear-resistant aluminum to eliminate cross leaks.
