Boost Valve & Sleeve Kit

86940-05K

Sonnax Part Summary

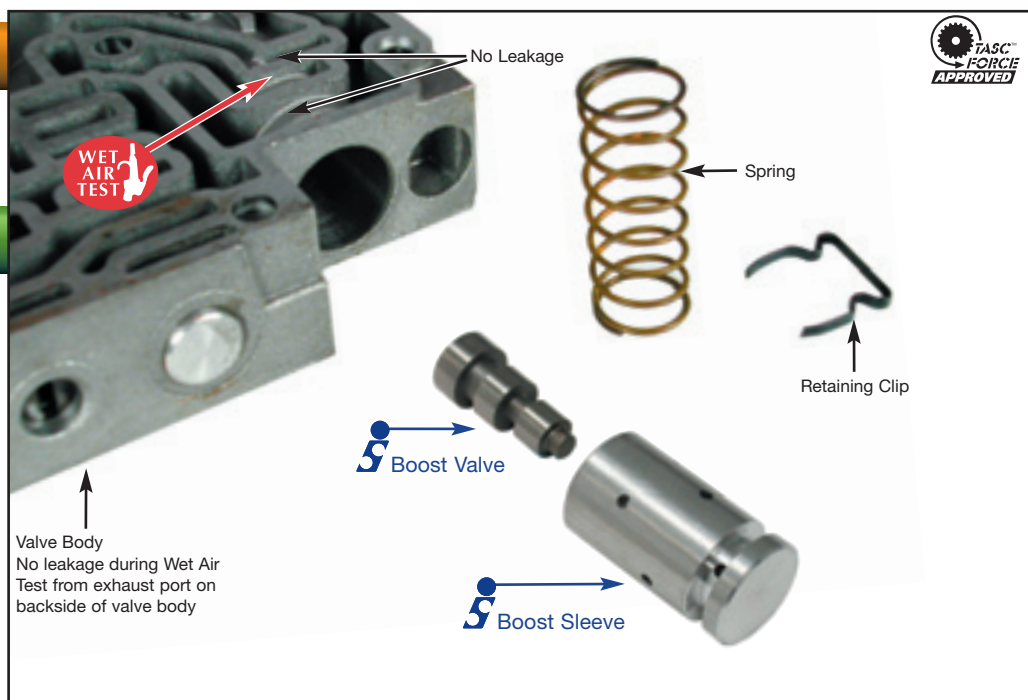
A worn boost valve sleeve allows TV boost and reverse pressures to cross leak or leak to exhaust.

This boost valve and sleeve kit restores the hydraulic integrity of the circuits with tight tolerances.
