**2nd gear damage from roller bearing**

**Main Shaft  
2nd Gear  
Thrust Washers**

**88406-SP  
88406B  
88406C**

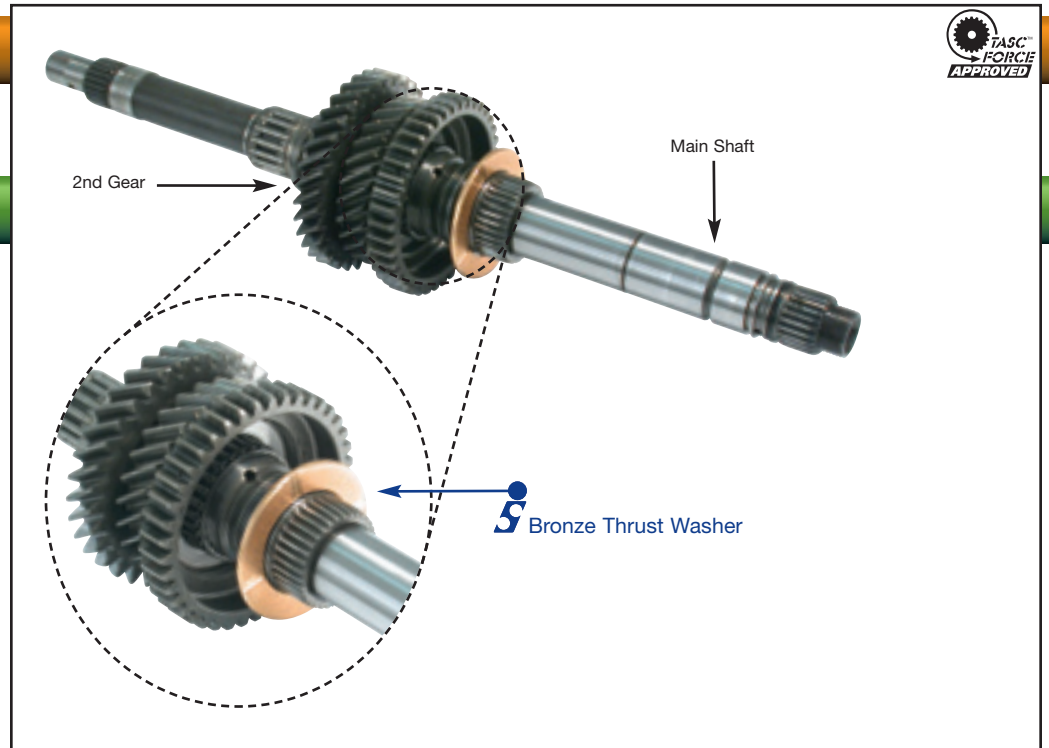
- Frequent roller bearing replacement

Axial thrust load of hardened needle rollers on softer gear.

**Note:** The gear thrust surface must be in good condition. A worn gear will cause failure.

These high-quality bronze thrust washers are designed to more effectively withstand the wear and axial thrust load of the mainshaft 2nd gear assembly.

On Honda 4-speed transmissions, the mainshaft 2nd gear wears severely from contact with the 2nd clutch needle roller bearing. This bearing also needs frequent replacement due to wear. The wear on the gear and the bearing is due to the axial thrust load on the assembly. Replace the needle bearing with Sonnax part number **88406-SP**, **88406B** or **88406C**. These high-quality bronze thrust washers are designed to more readily withstand the wear and axial thrust load of the mainshaft 2nd gear assembly.
