Main Shaft 2nd Gear Thrust Washers

88406-SP
88406B
88406C

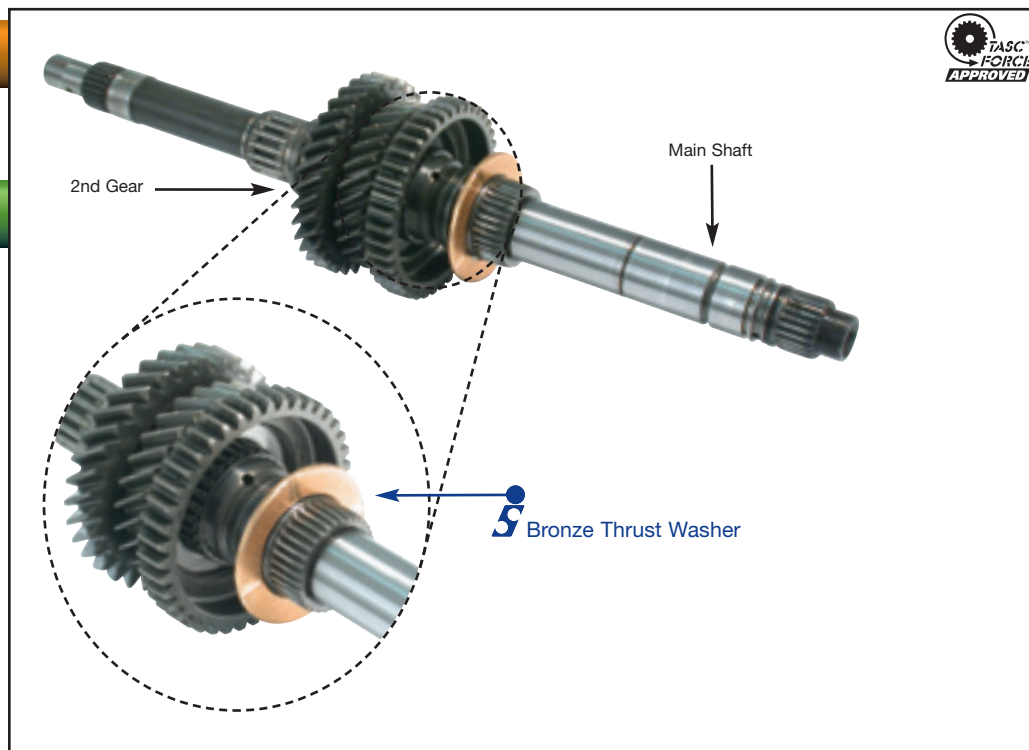
2nd gear damage from roller bearing

- Frequent roller bearing replacement

Axial thrust load of hardened needle rollers on softer gear.

Note: The gear thrust surface must be in good condition. A worn gear will cause failure.

These high-quality bronze thrust washers are designed to more effectively withstand the wear and axial thrust load of the mainshaft 2nd gear assembly.

On Honda 4-speed transmissions, the mainshaft 2nd gear wears severely from contact with the 2nd clutch needle roller bearing. This bearing also needs frequent replacement due to wear. The wear on the gear and the bearing is due to the axial thrust load on the assembly. Replace the needle bearing with Sonnax part number **88406-SP**, **88406B** or **88406C**. These high-quality bronze thrust washers are designed to more readily withstand the wear and axial thrust load of the mainshaft 2nd gear assembly.
