Solenoid Adjustment Tool

88950-T

Sonnax Part Summary

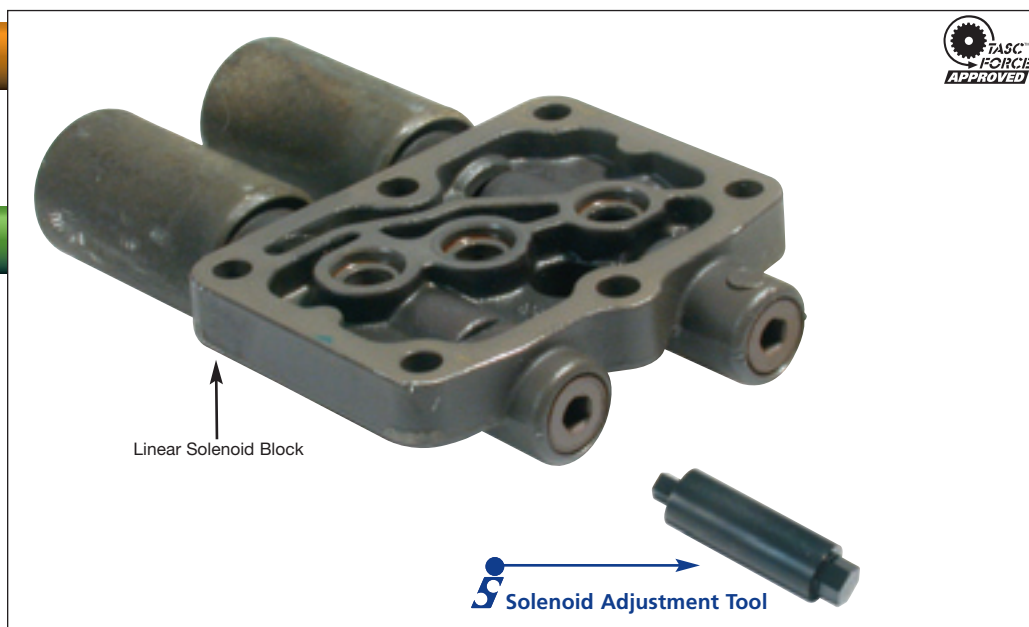
Soft shifts, low line rise

Incorrect or soft factory calibration of the linear solenoids, which can be aggravated by line pressure.

This special tool is designed to fit the pentagonal-shaped recesses in the clutch pressure control solenoids (linear), allowing them to be adjusted for firmer shifts.
