Accumulator Piston & Sleeve Kits

Sonnax Part Summary

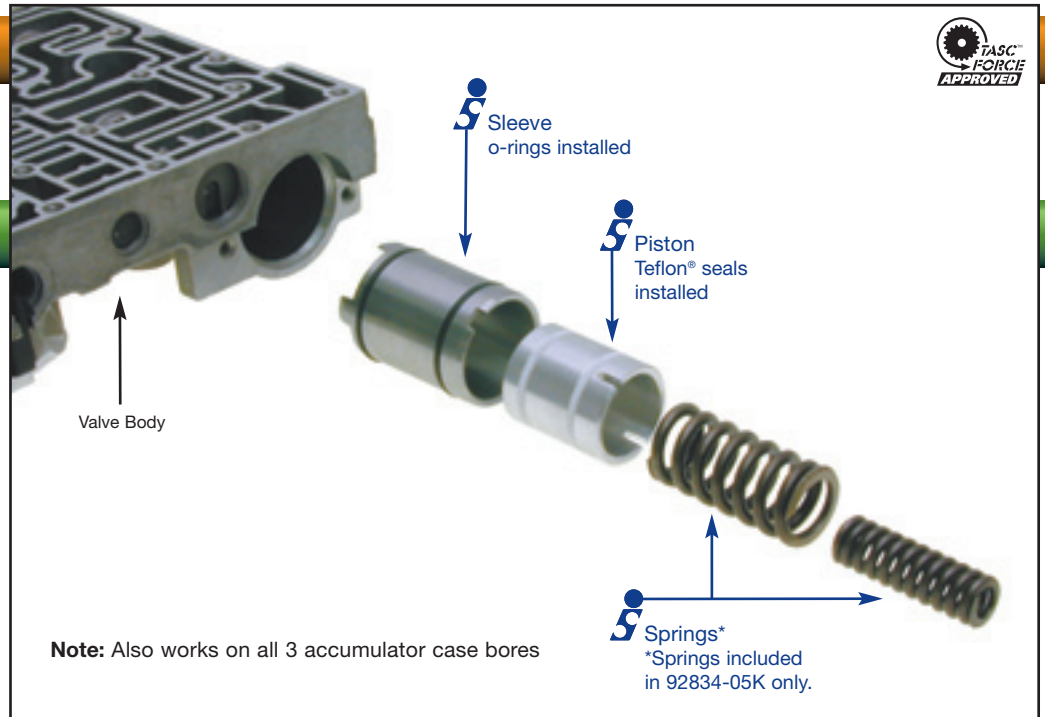
Scuffed and worn accumulator bores result in a poor seal and driveability complaints.

In 41TE/42LE transmissions it is common to have the accumulator bores scuffed and worn due to the rubbing action of the seals. This creates a poor seal resulting in driveability complaints of shudder or slide shifts. Sonnax now offers two accumulator bore sleeve and piston kits, **92834-03K** and **92834-05K**, that re-establish hydraulic integrity and save valuable cases and valve bodies.

These accumulator piston and sleeve kits provide a new bore along with pistons and seals designed to enhance sealing and durability.

Note: Also works on all 3 accumulator case bores
