Accumulator Piston & Sleeve Kits

Sonnax Part Summary

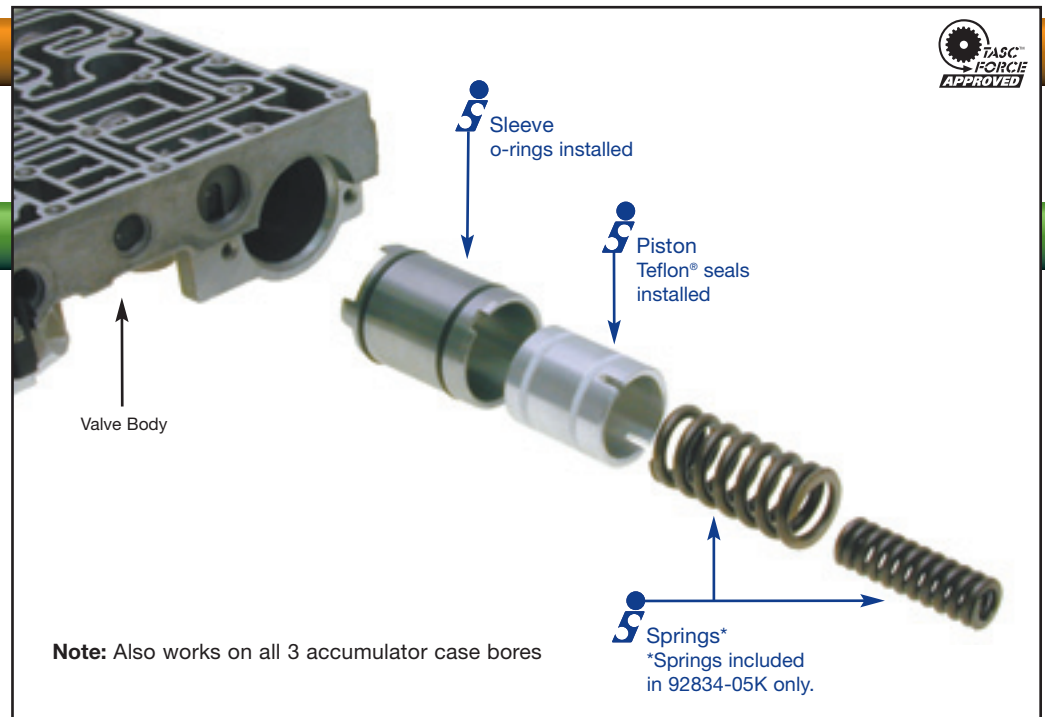
Scuffed and worn accumulator bores result in a poor seal and driveability complaints.

In 41TE/42LE transmissions it is common to have the accumulator bores scuffed and worn due to the rubbing action of the seals. This creates a poor seal resulting in driveability complaints of shudder or slide shifts. Sonnax now offers two accumulator bore sleeve and piston kits, **92834-03K** and **92834-05K**, that re-establish hydraulic integrity and save valuable cases and valve bodies.

These accumulator piston and sleeve kits provide a new bore along with pistons and seals designed to enhance sealing and durability.
