## COMPLAINT

### Erratic or no TCC, 2nd gear starts

## Solenoid Switch Valve Plug Kits

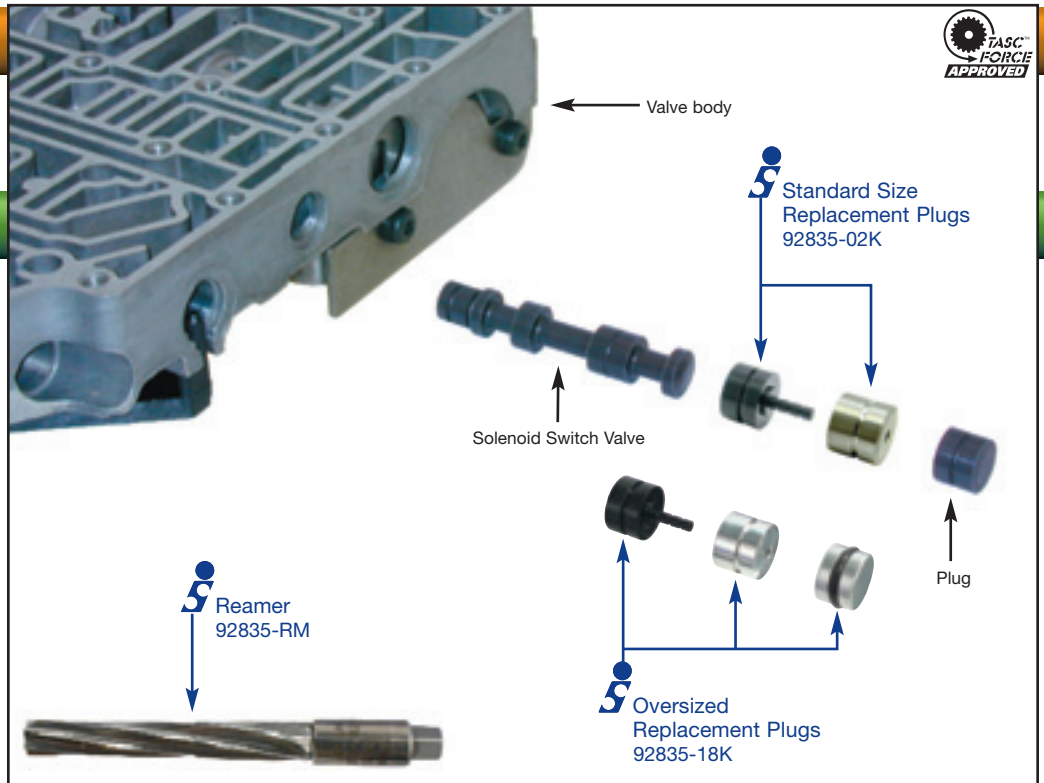
Solenoid switch valve plugs cocking in the bore and/or bore wear at the switch valves.

The replacement switch valve plugs have a guide stem that connects the two halves and prevents valve cocking. Available in standard-sized drop-in replacements or newly available oversized replacements.
