# 41TE, 42LE

**PART NUMBER 92835-07**

### Pressure Regulator Reducing Sleeve

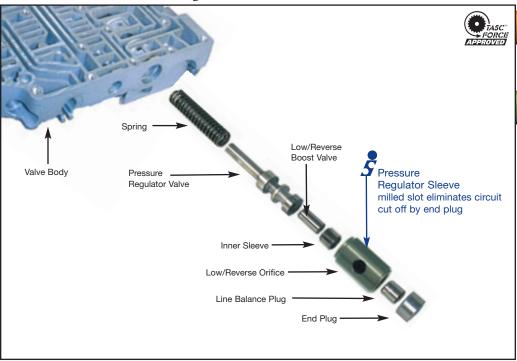
#### 92835-07

A worn pressure regulator reducing sleeve allows oil leakage.

### High line pressure, erratic converter apply pressure

• Poor lube control • Harsh shifting

This replacement pressure regulator reducing sleeve eliminates oil loss and cross leakage.
