### **41TE** ('94 TO '97 W/INTERNAL BYPASS VALVE)

PART NUMBER 92836-01K

### **Bypass Plug**

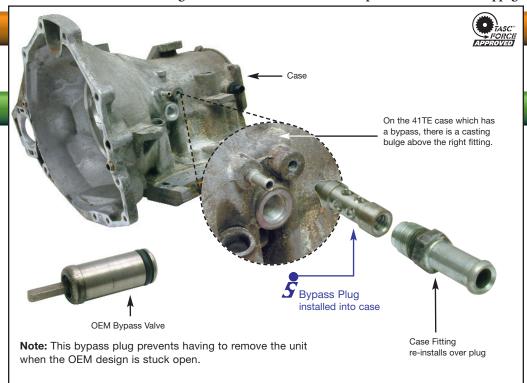
The cooler bypass valve may be stuck open, reducing converter apply pressure.

### Lockup shudder, low cooler flow

• Erratic switch codes • Soft, long 1-2 shift • Erratic coastdown bumps • Converter clutch slippage

This bypass plug disables the OEM bypass valve and directs all fluid through the cooler.
