COMPLAINT

Intermittent pressure switch codes (21, 22, 23 & 24)

Solenoid Pack Rubber Diaphragm &/or Brass Contact Repair

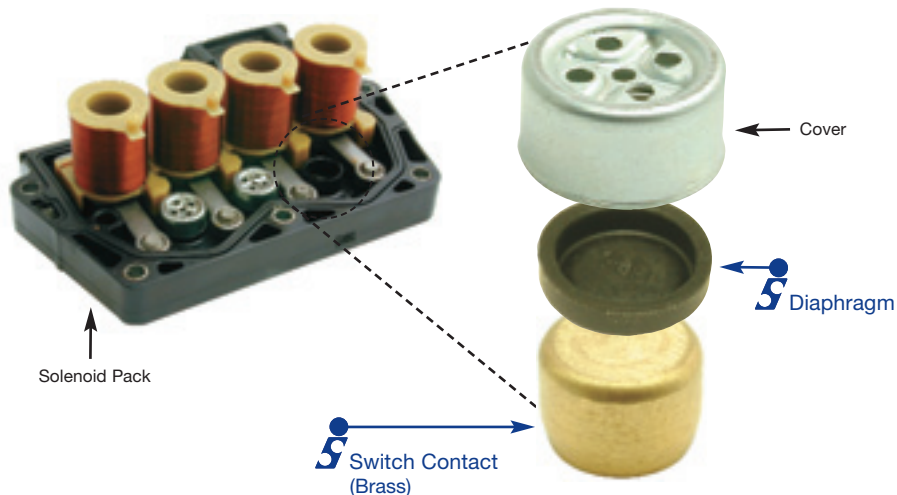
Worn switch contacts and leaking switch seals or replacement seals that are too thick.

The 41TE and 42LE solenoid packs are easy to rebuild. Getting parts that work is another story. Oftentimes, the brass switch contacts bind in the housing bore, or the switch diaphragms are too thick to allow proper switch operation. These problems are often the cause of switch codes and continuous “limp-in” complaints. The Sonnax rubber diaphragms match OEM specifications, and the switch contacts are specially dimensioned to prevent false/intermittent switch codes. It is no longer necessary to purchase a solenoid pack from the dealer just to get the right contacts and diaphragms.

Replace worn diaphragm and switch contact with the properly dimensioned parts.
