## Pressure Regulator Boost Sleeve

**93990**

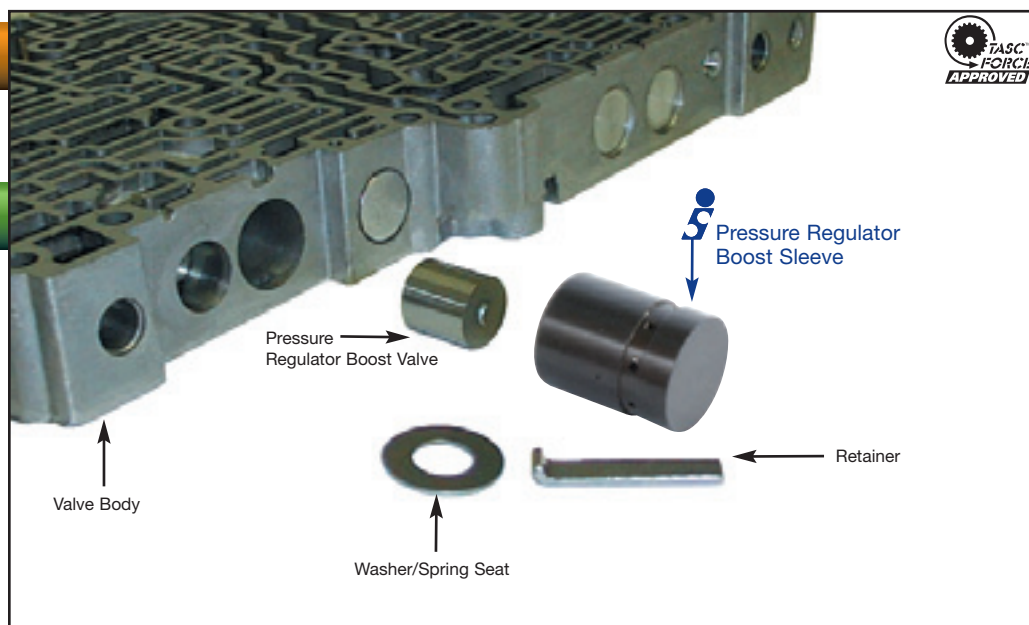
1 Boost Sleeve

Poor shift timing, insufficient line rise

The regulator boost valve wears the inside diameter of the boost sleeve.

Vehicles with a RL4F02A transmission often have problems with poor shift timing and poor line rise. This can be caused by the reciprocating pressure regulator boost valve wearing the inside diameter of the boost sleeve. As this wear increases, pilot/boost pressure, which enters the sleeve, leaks past the valve and exhausts, resulting in poor line rise. The Sonnax replacement pressure regulator boost sleeve **93990** eliminates the above problems.

This replacement pressure regulator boost sleeve is tightly toleranced to restore proper line rise control.

- Sleeve has been manufactured from high-quality aluminum designed to resist wear.
- Sleeve has been closely toleranced to obtain the original minimal clearance with the boost valve.
