Upgraded Front Sun Gear Shell Bushing

96009-01

Sonnax Part Summary

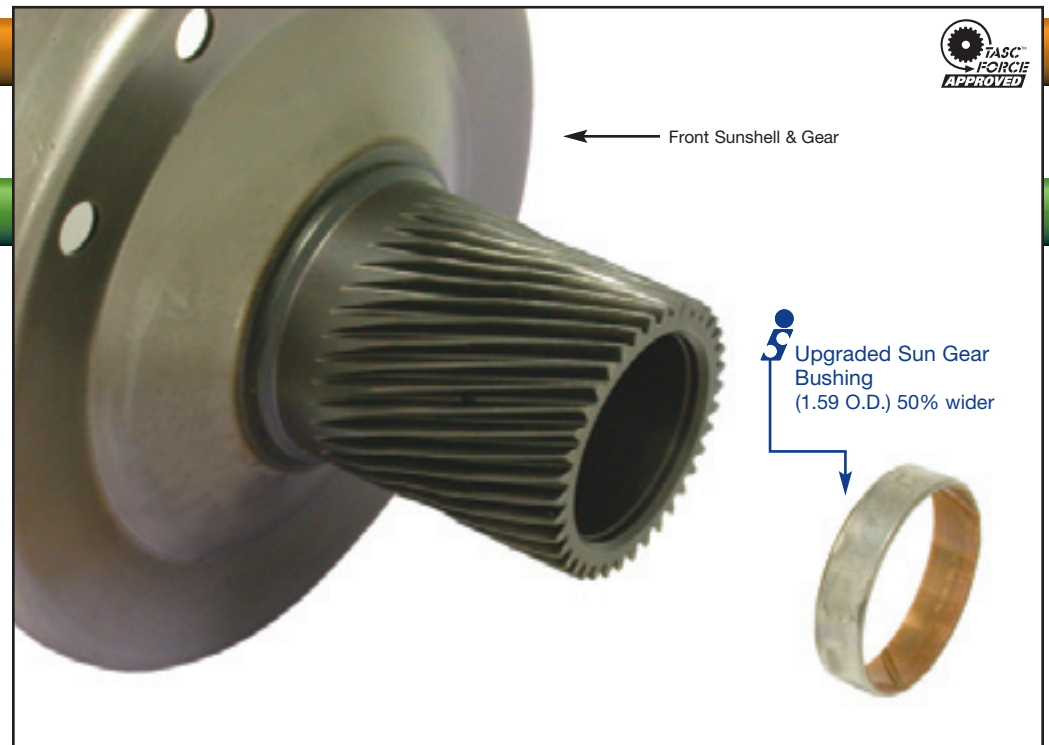
Lower sun gear shell bushings wear prematurely

- Loss of lube oil

OEM and aftermarket bushings are too narrow for application.

In vehicles with AXOD & E ('88-'92) transmissions it is common for the lower sun gear bushing to wear. The sun gear holds two bushings, an upper and lower bushing. The upgraded Sonnax bushing **96009-01** replaces the lower and upper sun gear bushings.

This wider bushing gives more support and reduces shaft-to-bushing clearance.

- The Sonnax bushing is 50% wider for better support.
- Bushing has less bushing-to-shaft clearance than other available bushings.
