## **AXODE, AX4S**

PART NUMBERS 96201-16K, -BST

# Forward Control Valve & Bore Sizing Tool

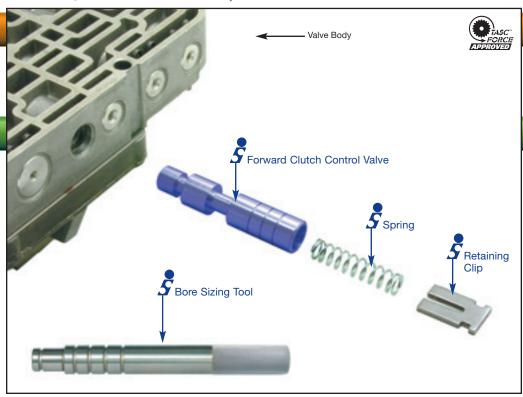
The spring stem of the OEM valve repeatedly bangs the clip, resulting in damaged bore components and a stuck valve.

The forward clutch control valve strokes to turn the forward clutch on and off. Each time it strokes to the on position, the valve's narrow spring stem bangs against the steel retainer. This constant banging can eventually break the retainer. The broken retainer forces the valve off center, often bending the valve, or worse, the valve pushes right through the retainer. The problem depends on where the valve sticks, and whether the valve has broken through the plate. Sonnax has developed a replacement valve kit **96201-16K** that corrects these problems.

Resize the bore with this sizing tool and install the replacement valve with multiple improved features.

- Valve has a longer and sturdier spool, eliminating the OEM stem and allows a larger contact area with the retainer, preventing the valve from bending or breaking.
- Annular grooves are added to the spool to properly center the valve and prevent wear.
- Valve kit includes a replacement spring and retainer.
- Bore can be quickly and easily resized using the Sonnax resizing tool 96201-BST.
