Forward Control Valve & Bore Sizing Tool

96206-07K

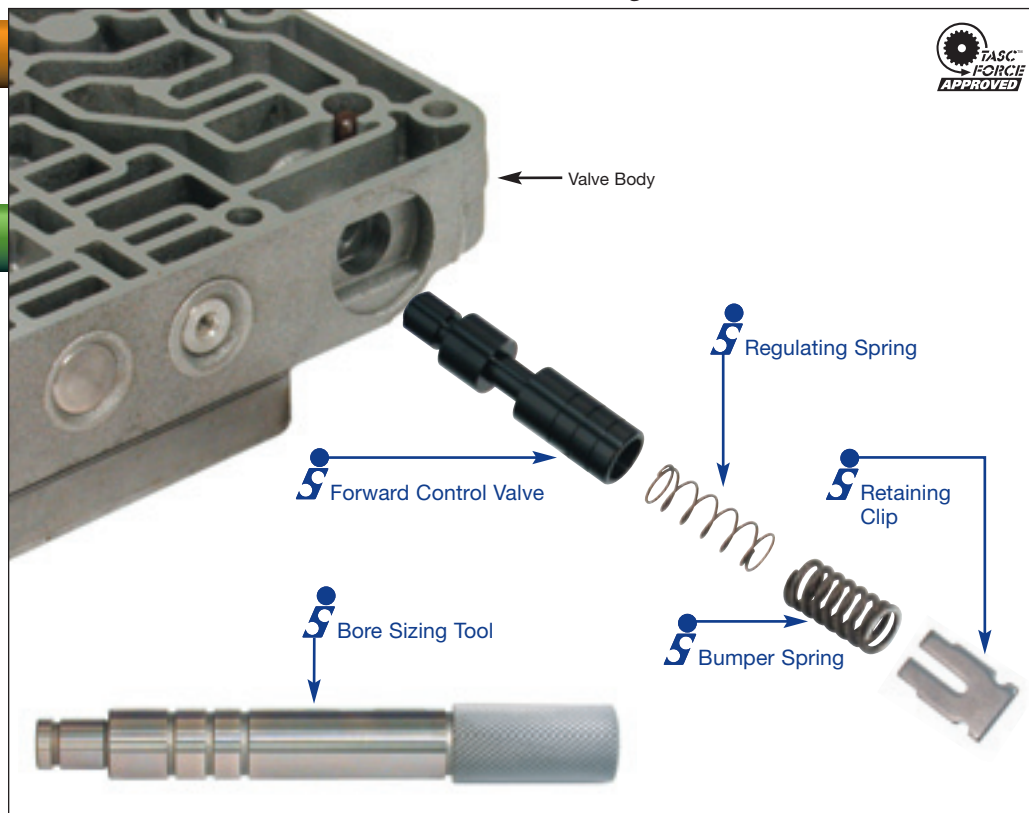
Forward control valve is bent or sticking from the stem, smashing into the retainer clip.

The front stem of the aluminum OEM forward control valve bangs against the steel retaining clip when stroked. The force of this constant banging often causes the valve to warp and seize in the bore, as well as breaking the OEM clip. No valve movement can result in a neutralling-out complaint, no 4th gear or a burned forward clutch. The Sonnax forward control valve **96206-07K** corrects these problems.

Resize the bore with this sizing tool and install the modified valve with multiple improved features.
