Line Pressure Modulator Valve & Sleeve

Sonnax Part Summary:

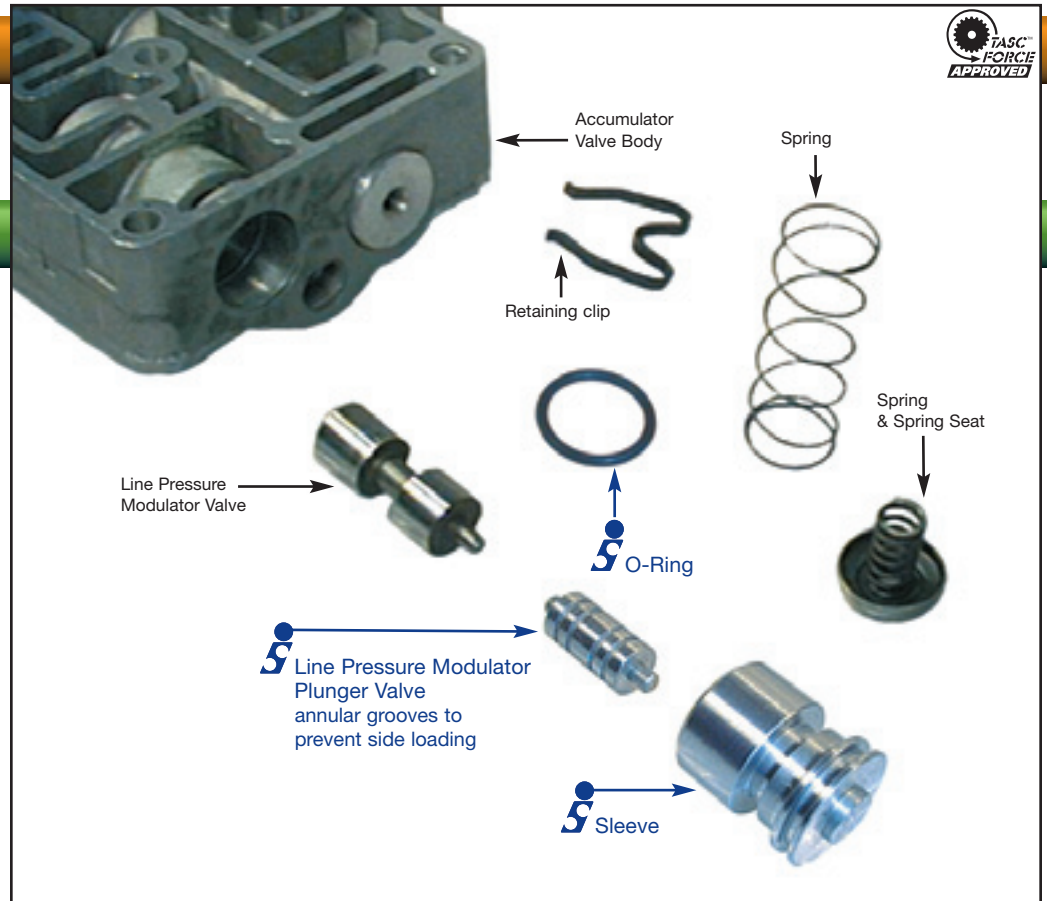
Soft 1-2 and/or 2-3 shifts, intermittent harsh shifts

- Low EPC pressure • Poor line rise

Severe wear of line pressure modulator sleeve allows EPC oil leakage and /or plunger valve hang-up.

Sonnax offers four variations of this line pressure modulator sleeve and valve kit that prevent excessive EPC oil loss.
