## Poor reverse boost, delayed reverse

## Large Reverse Boost Valve & Sleeve

### K77898

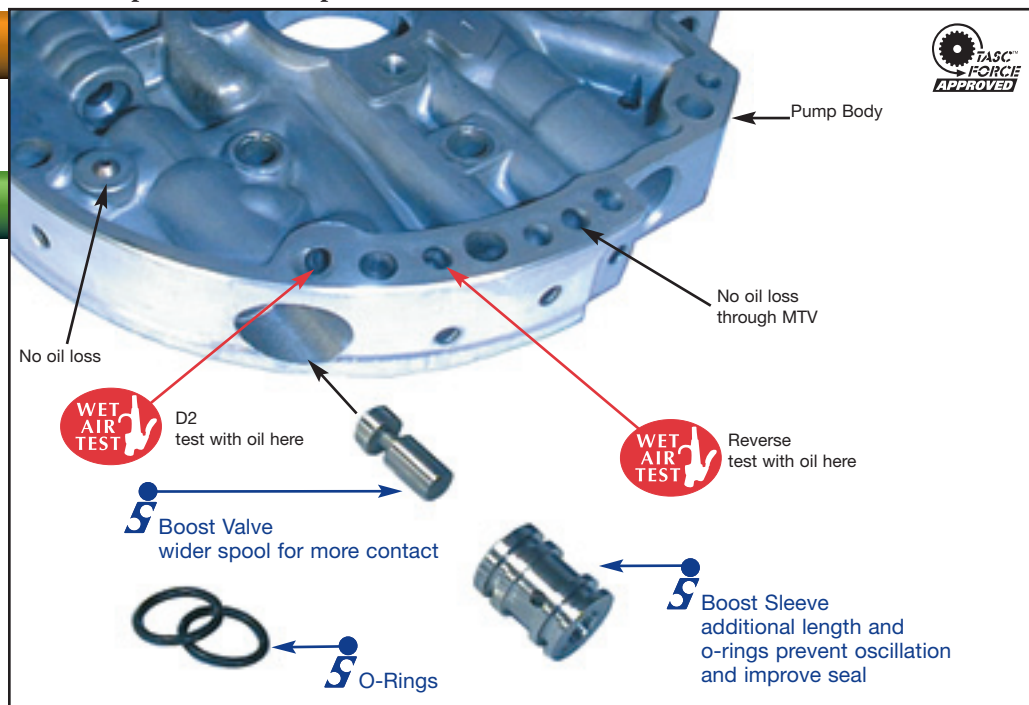
• Low line pressure • Poor upshift in manual low

Worn reverse boost valve sleeve or wear at pump body.

Vehicles with a 4L60 transmission often have problems with poor reverse boost or upshifts in manual low. These are generally caused by a worn reverse boost valve sleeve or wear at the pump body. Sonnax now offers the larger (.283") reverse boost valve assembly **K77898**, which restores the hydraulic integrity of the assembly. Due to the differences in the thermal expansion rate of steel and aluminum when the transmission approaches operating temperature, the sleeve has been allowed excessive clearance and scrubs the bore.

This large reverse boost valve assembly is made from hardened steel and o-rings have been added to seal the reverse boost circuit and prevent leakage.

- Sleeve and valve are made from hardened steel for increased wear resistance.
- O-rings added to the boost sleeve seal the reverse boost circuit and prevent leakage from the pump body bore.
- Sleeve lands have been lengthened to add better sealing and stabilizing capabilities to prevent bore wear.
- The reverse boost valve spool lands have been lengthened to aid in maintaining hydraulic integrity.
