2-3, 3-2 shift concern

B4 Release Valve Kit

59947-26K

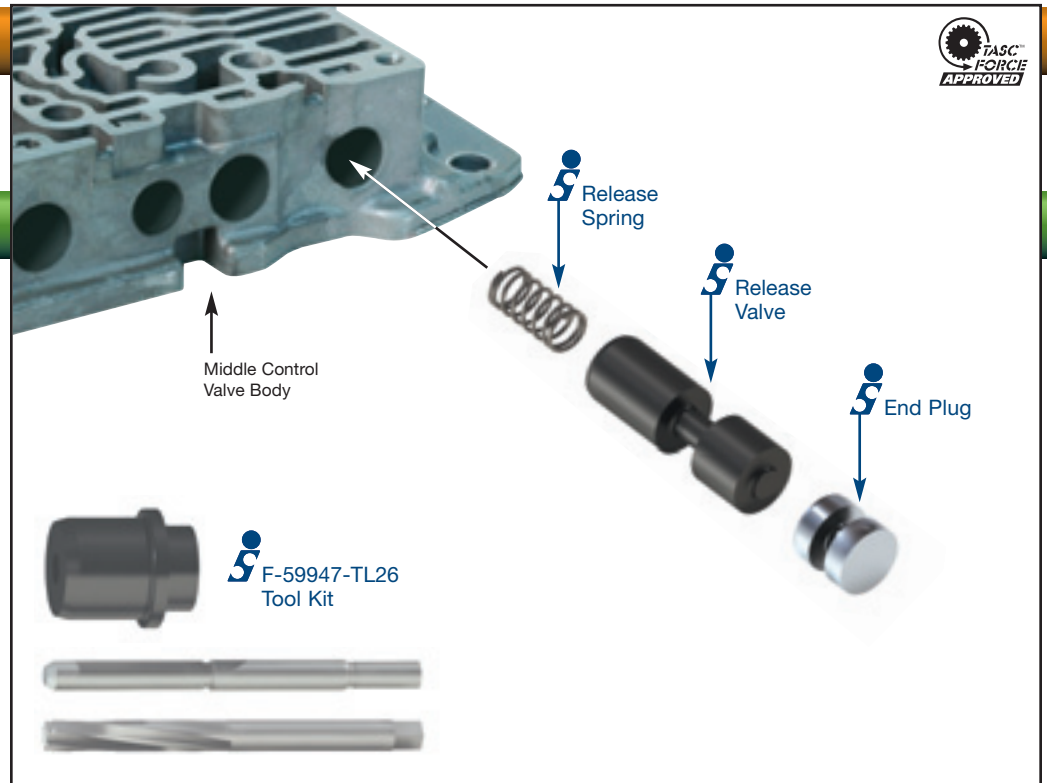
- 1 Release Valve
- 1 Spring
- 1 End Plug

- 1 Reamer
- 1 Guide Pin
- 1 Reamer Jig

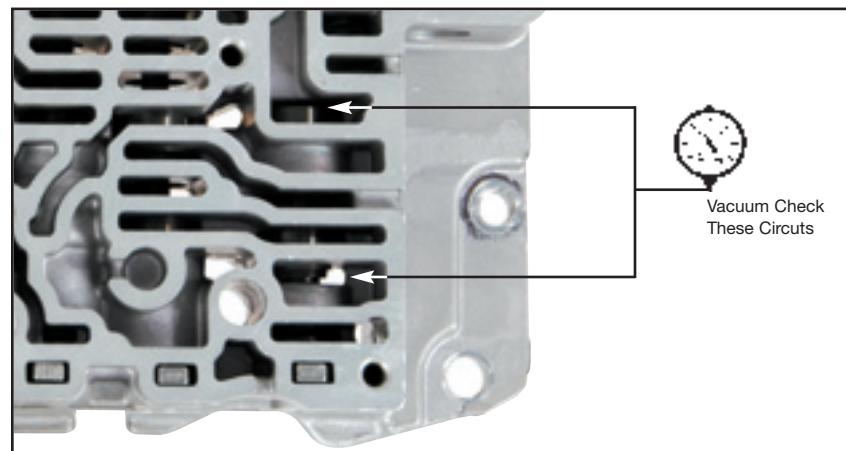
You need this if...

Vacuum tests at the ports indicated do not hold 18" or more.

Note: For information on proper vacuum test procedures, go to www.sonnax.com, click on "Technical Information" and go to Vacuum Testing Guidelines Instructions.
