F-Clutch Drum Bushing & Sealing Ring Kit

85110-01K

Sonnax Part Summary

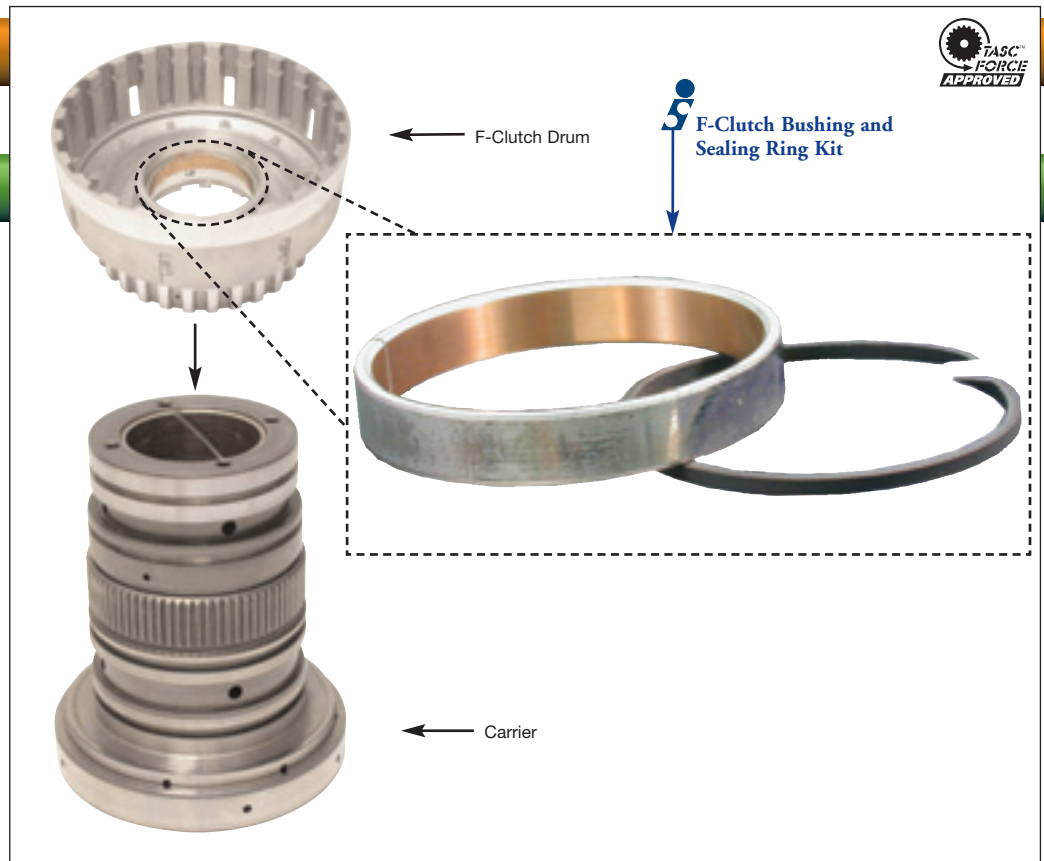
1 Sealing Ring
1 Bushing

Note: Fits early bushing-style ZF5HP19.

The OEM sealing ring cuts a groove into the F-Clutch drum bushing and reduces the sealing ability of the seal and bushing.

The Sonnax steel-backed bushing and sealing ring restore forward clutch oil pressure.

- Bushing and sealing ring now available separately, enabling salvage of drum.
- Steel-backed bronze bushing is OEM equivalent.
- Kit restores hydraulic integrity to clutch circuit, preventing loss of forward clutch oil.
