## Pressure regulation codes, Default mode

## Oversized Pressure Regulator Valve Repair Kit

### 120940-01K

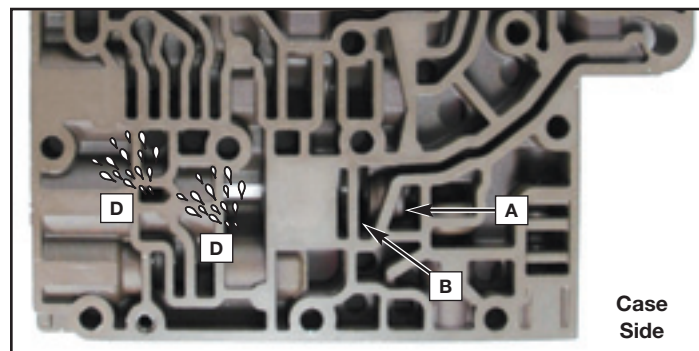
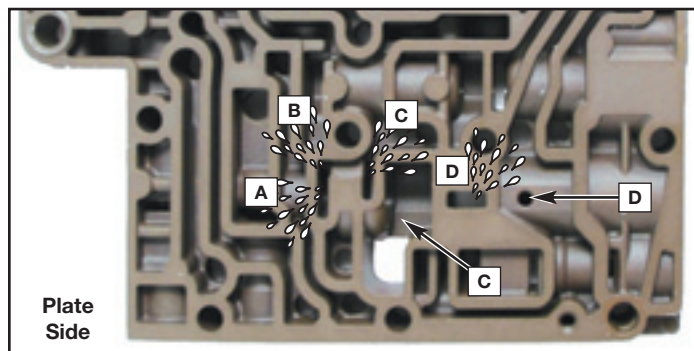
Vacuum tests at the ports indicated (A, B, C & D) do not hold 18" or if a Wet Air Test at the same locations result in leaking at the corresponding ports.

**Key:** Vacuum or WAT where indicated by a "Lettered" arrow and check results by the corresponding "Lettered" spray.

Excessive OE plunger valve and bore wear results in high line pressure conditions. Excessive wear of the OE pressure regulator valve and bore may cause low, high or unstable line pressure issues. When installed, the Sonnax pressure regulator valve repair kit, **120940-01K**, restores correct pressure regulator and plunger valve operation to provide appropriate line pressure for all operating conditions.
