No reverse or slip after low/reverse drum resurfacing

Oversized Band Strut

Sonnax Part Summary

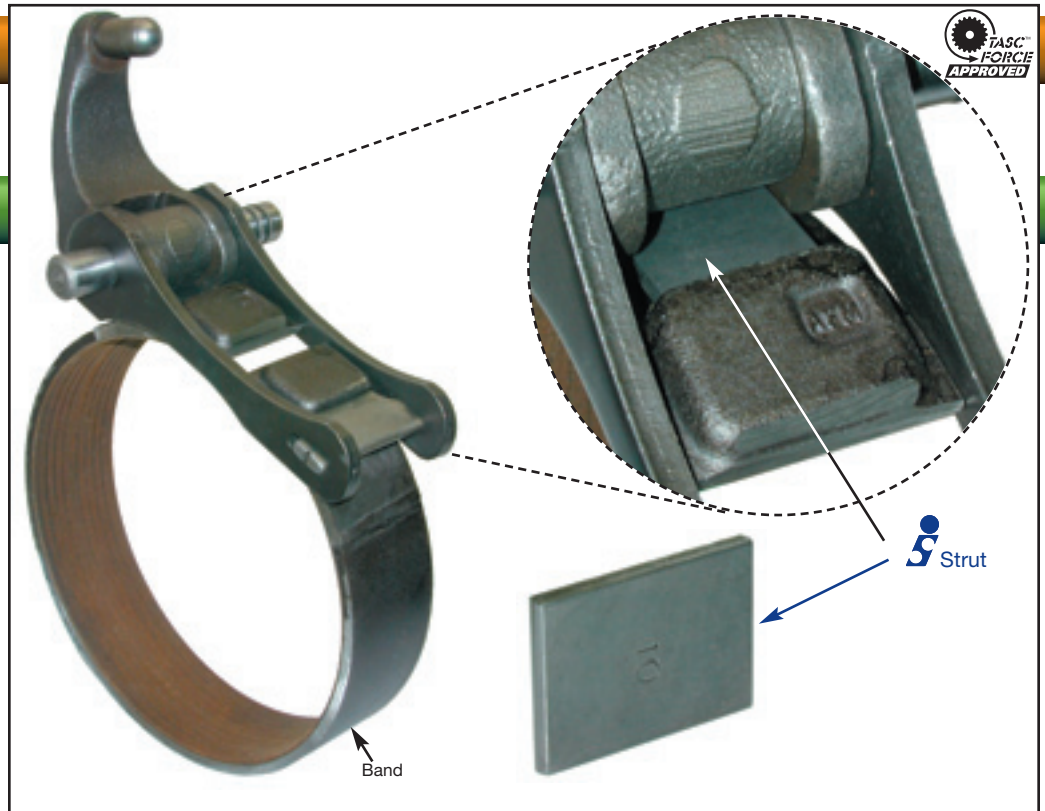
1 Oversized Band Strut, .100"

1 Oversized Band Strut, .150"

These extended length struts compensate for material removed by machining when used drums are salvaged by machining the outer diameter.

After the low/reverse brake drum has been resurfaced and the brake band has been relined, the band may not hold during apply, causing a slip or no reverse. Sonnax has designed two extended struts, **22900-10** and **22900-15** to address these problems..

- **22900-10** is .100" longer and **22900-15** is .150" longer to regain correct band adjustment.
- Use of these struts eliminates the need to use specially relined bands with a thicker lining.
