Oversized Pressure Regulator and Boost Valve Kit

27741-08K

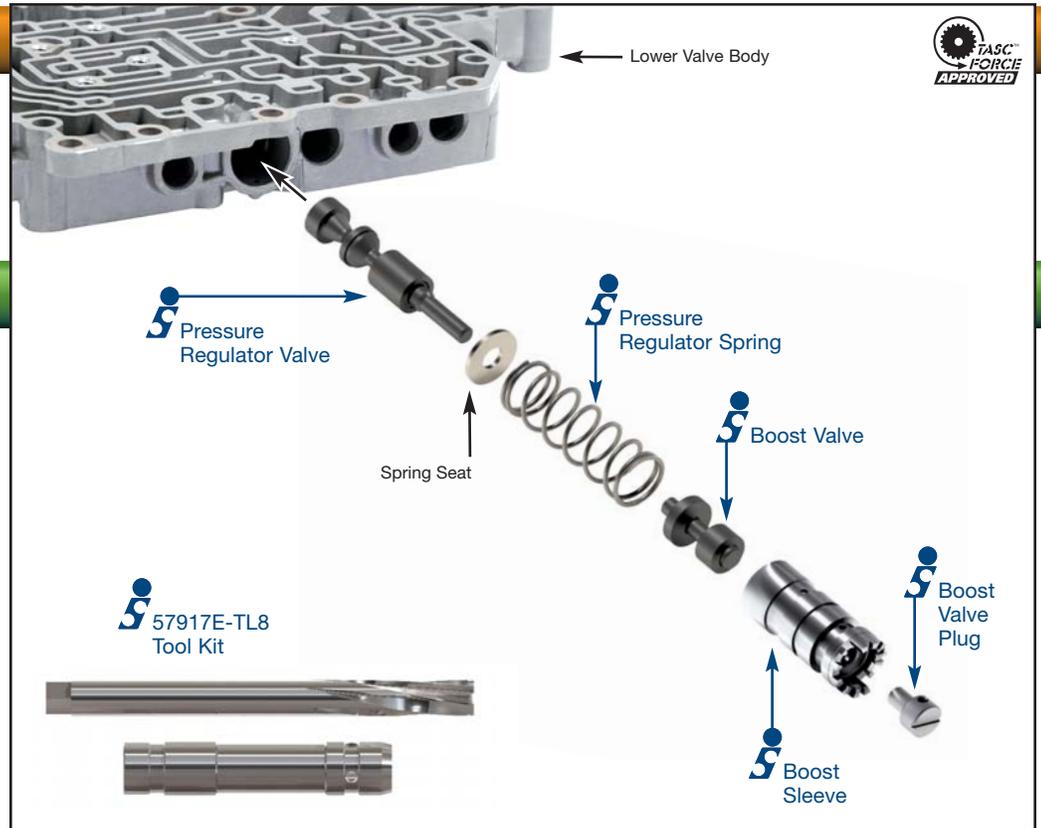
- 1 Pressure Regulator Valve
- 1 Pressure Regulator Spring
- 1 Boost Valve
- 1 Boost Sleeve
- 1 Boost Valve Plug

- 1 Reamer
- 1 Reamer Jig

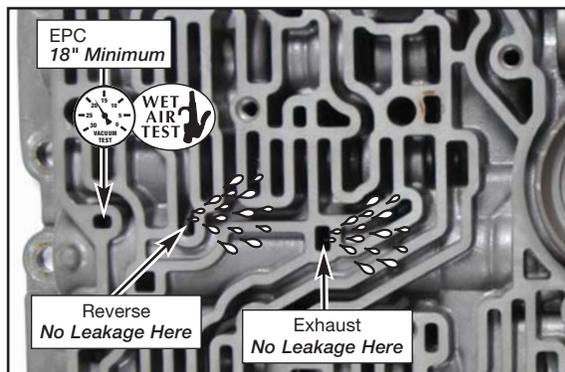
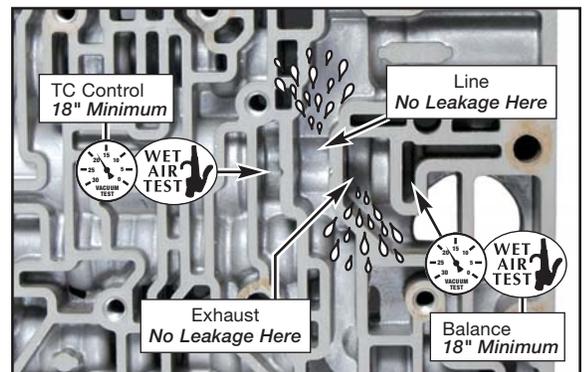
Either a Wet Air Test or a Vacuum Test in the location shown, results in leakage. A vacuum test must hold a minimum of 18".

This oversized pressure regulator valve and boost assembly allows the valve body bore to be restored to normal operating condition.
