TCC Regulated Apply Valve Sleeve

Sonnax Part Summary

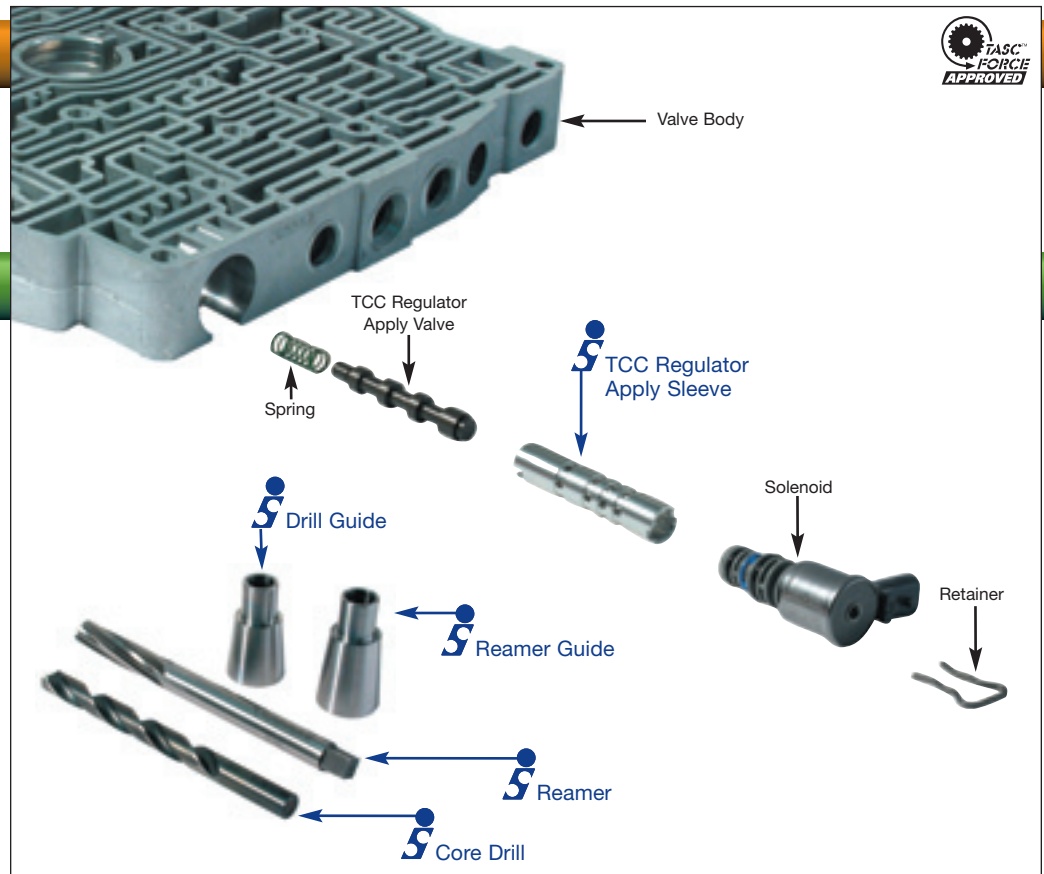
TCC regulated apply valve bore wear can cause the apply valve to stick in the apply or release positions, resulting in the TCC not applying or soft or harsh TCC applies.

33000-02
TCC Regulator Apply Sleeve

33000-TL
1 Core Drill
1 Drill Guide
1 Reamer
1 Reamer Guide

Install this TCC regulated apply valve sleeve kit by oversizing the OEM bore with the drill and reamer kit.

- Sleeve is installed using the original OEM valve, allowing the bore to be restored, and eliminating sticking.
- Sleeve is made from high-quality aluminum to resist wear and increase longevity.
