4th Accumulator Bore Sleeve & Pinless Accumulator Piston Kit

34805-01K

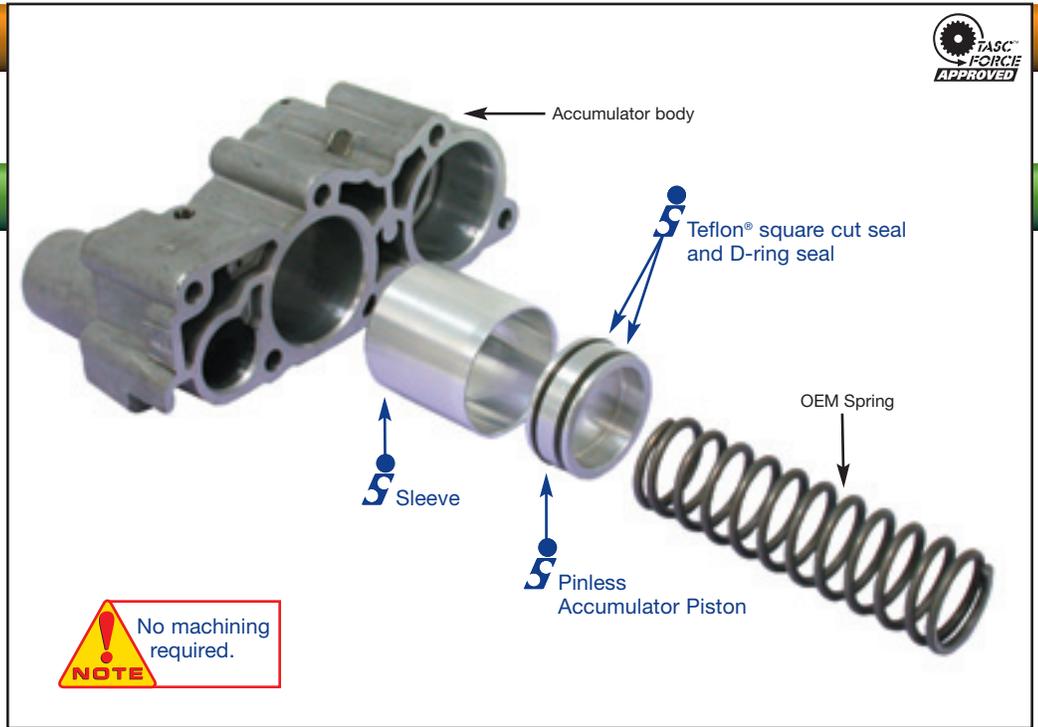
- 1 Sleeve
- 1 Pinless Accumulator Piston
- 1 Teflon® Seal
- 1 D-Ring Seal
- 1 Pin Bore Plug

Repeated reciprocation of the 4th accumulator piston causes wear at the piston/pin interface. After this wear reaches a critical point, the piston bore wear allows the piston to get cocked and gall the accumulator bore. Once this bore becomes severely galled, the accumulator body must be replaced. The Sonnax kit **34805-01K** salvages accumulator housings with a worn or scored 4th accumulator bore. The kit includes a press-in sleeve, and a pinless accumulator piston that uses a Teflon® guide ring to support the piston in the bore. No machining is required.

Install this sleeve and pinless accumulator piston.

- Kit salvages accumulator housings with a worn or scored 4th accumulator bore.
- A press-in sleeve is included for easy installation.
- Pinless accumulator piston uses a Teflon® guide ring to support the piston in the bore.
