Flare upshifts or downshift bind-ups

C3 Clutch Control Valve Kit

39741-08K

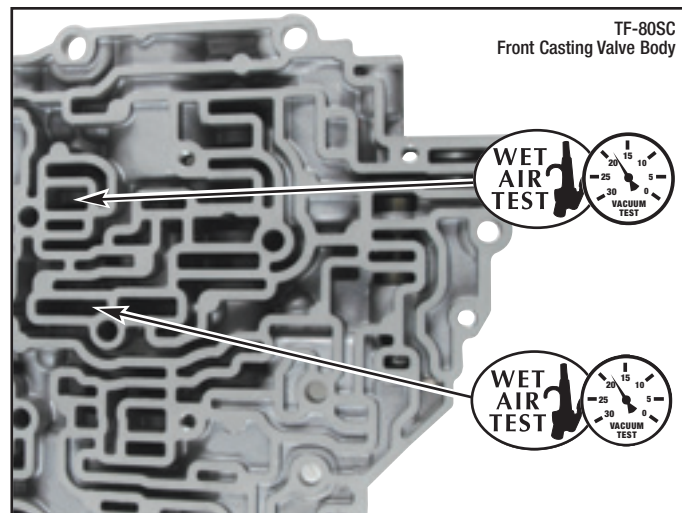
Either a Wet Air Test or a Vacuum Test in the locations shown, result in leakage. A vacuum test must hold a minimum of 18".
