Accumulator Cover Plate

44892-01K

Sonnax Part Summary

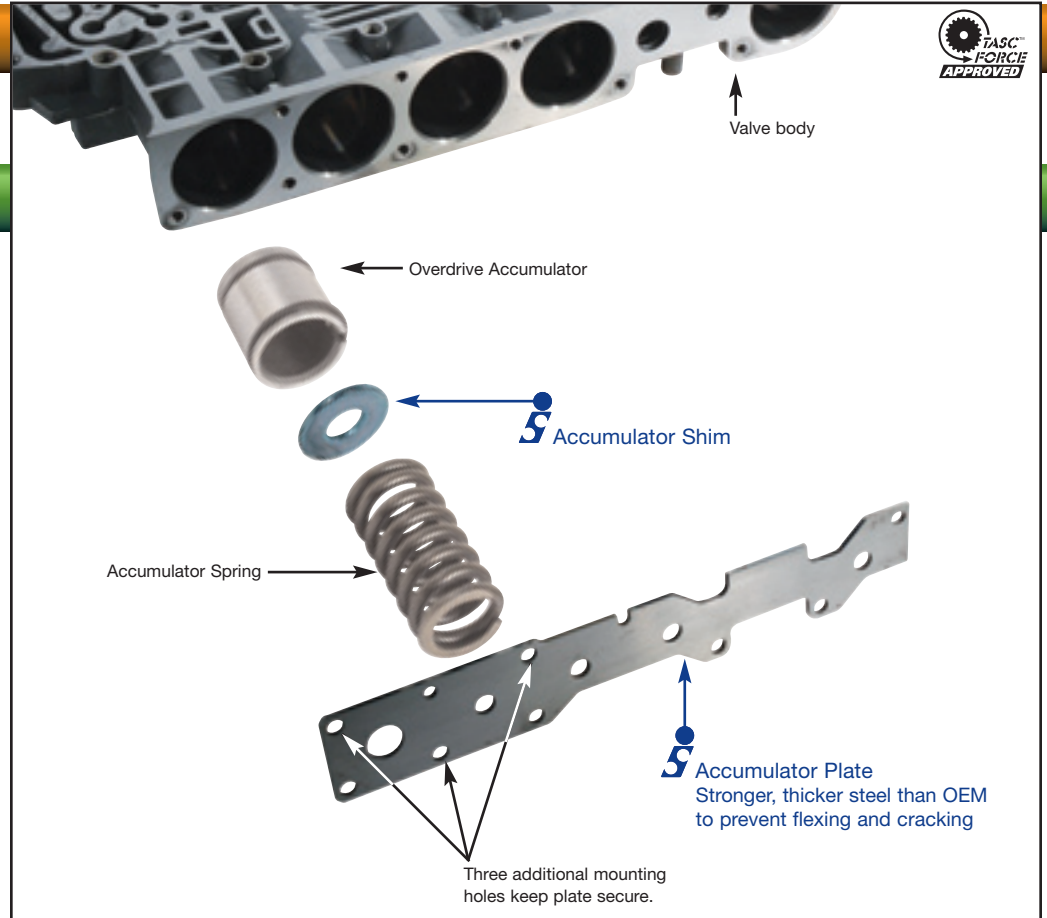
Damaged/cracked accumulator plate

The OEM plate flexes, causing the screws to loosen and break.

The Sonnax replacement plate is made from stronger, thicker steel and has three additional screw holes and stronger screws to ensure the plate is held securely.

The accumulator plate in 45RFE and 545RFE units is weak and not held securely enough to withstand the action of the accumulator pistons. The OEM plate flexes, causing the screws to loosen and break. The Sonnax improved accumulator plate **44892-01K** is an upgrade over the OEM plate and allows salvage of valve bodies with damaged plates. The plate is made of thicker steel and has three additional screw holes to hold the plate more securely. The 44892-TL thread tap forms stronger threads in the aluminum valve body.

- Accumulator plate is made from stronger, thicker material to prevent flexing.
- Three additional mounting holes and high torque-rated screws prevent the plate or screws from coming loose from normal vibration.
- Specially graded tap provides higher torque yield threads.
