## Crankshaft Spacers

### Sonnax Part Summary

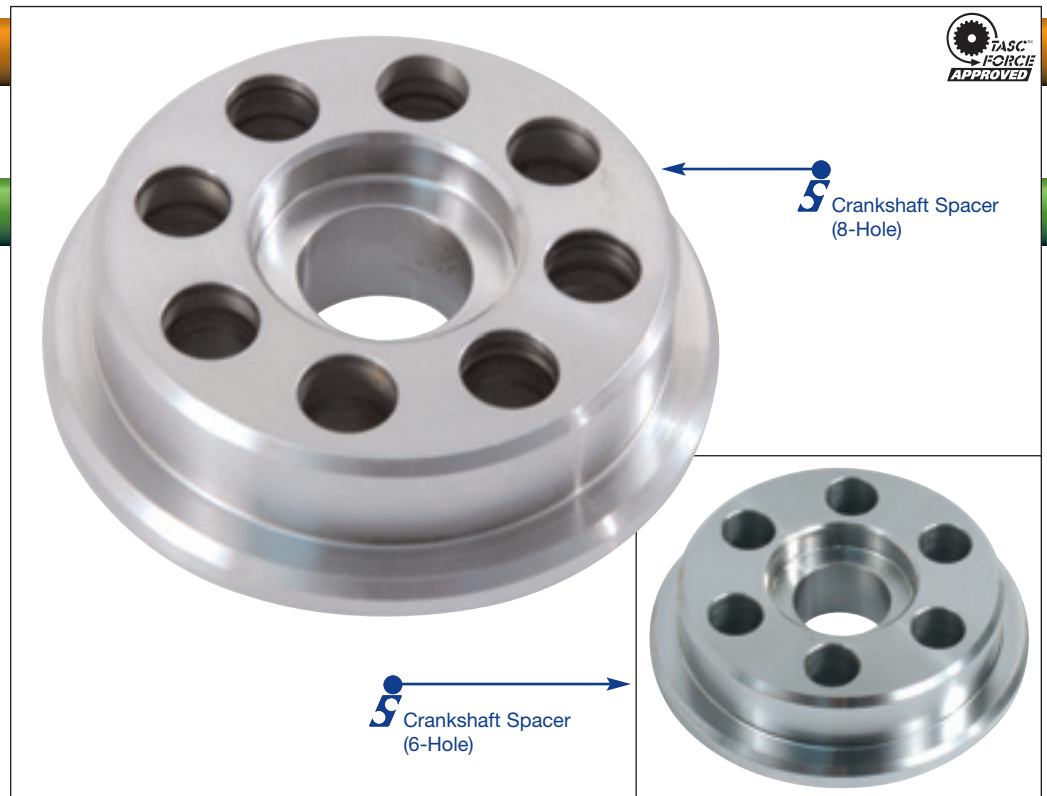
Cracked or worn crankshaft spacer, front pump/converter seal leaks

• Vibration • Cracked flywheel • Converter misalignment when bolts are tightened

Lack of support for the torque converter pilot in the crankshaft spacer.

The crankshaft spacer in A4LD, 4R44E and 5R55E applications is prone to cracking and wear because the powdered metal material of the OE spacer cannot provide adequate support for the torque converter pilot. Once the spacer wears or breaks, the result is converter misalignment.

The Sonnax billet steel spacer will not wear or break as the OEM powdered metal spacer does.

- Sonnax billet steel crankshaft spacers are significantly more durable than the OE powdered metal version.
- Eliminates concern of repeat breakage and wear.
- Both are simple drop-in replacements.
