## Governor Bore Sleeve

**69835**

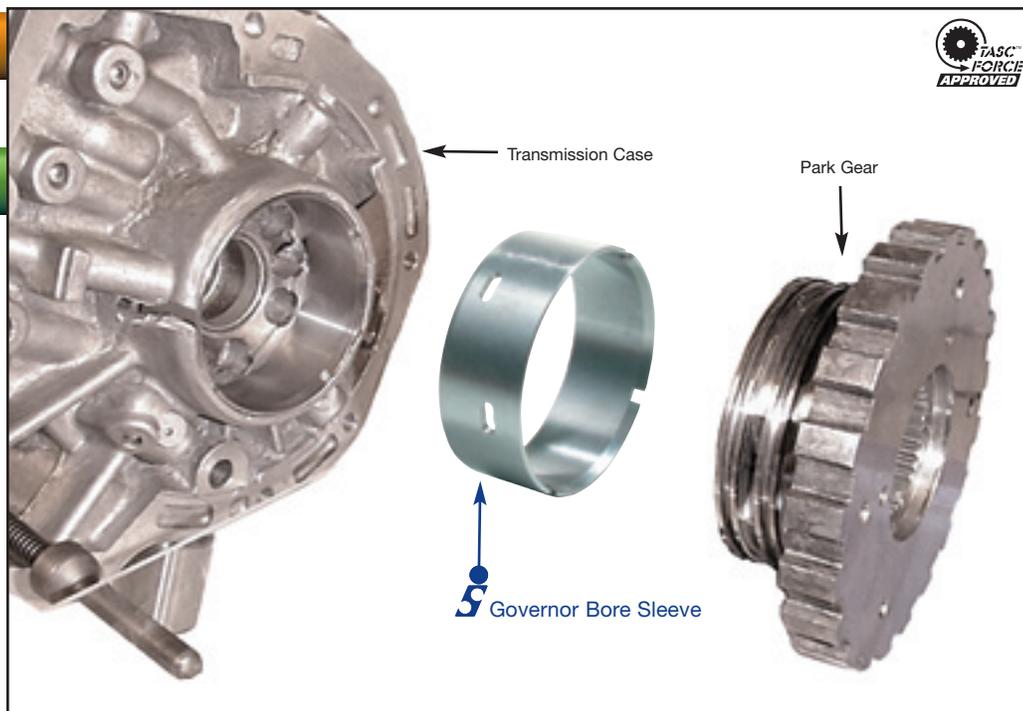
1 Governor Bore Sleeve

Worn and scored governor bores.

The governor sleeve on the RL4R01A case wears and becomes scored. After the sleeve is worn excessively, the case has to be replaced. Sonnax now offers a replacement sleeve **69835** that allows the rebuilder to reuse cases with worn governor sleeves.

This replacement sleeve provides a new surface for the rings to seal properly.
