Servo Pin Bore Sleeve

76890-24K

Sonnax Part Summary

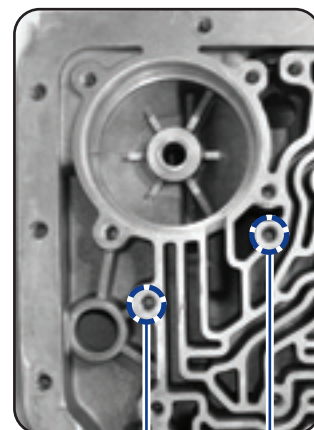
4L30-E & 180 Cases

Fixture mounting hole
locations for 1-2 band
