Throttle Boost Valve & Sleeve

Sonnax Part Summary

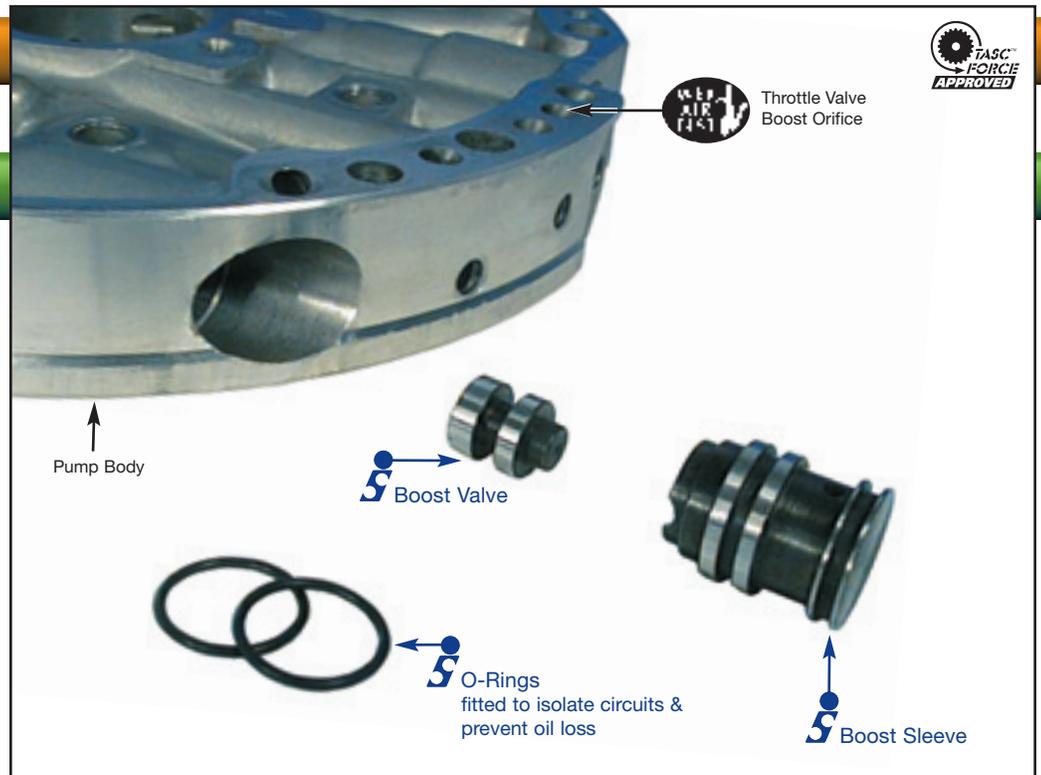
These replacement assemblies prevent oil loss between the outside diameter of the TV sleeve and the pump body.

- 1 Boost Valve
- 1 Boost Sleeve
- 2 O-Rings

- Throttle valve boost valve and sleeve are made from made from hardened steel for better wear resistance.
- O-rings on sleeve separate throttle pressure and reverse boost circuits, providing additional protection against cross leaks.
- O-rings prevent loss of oil between the outside diameter of the throttle valve sleeve and pump body.

A common problem in 4L60 transmissions is burned bands and/or 3-4 clutches. This failure can be reduced by eliminating throttle boost oil leakage. The Sonnax replacement assemblies **77917-01K** (.423" diameter), **77917-471** (.471" diameter) and **77917-500** (500" diameter) eliminate these problems for a variety of applications.
