Direct Replacement Throttle Valve

77968-02

Sonnax Part Summary

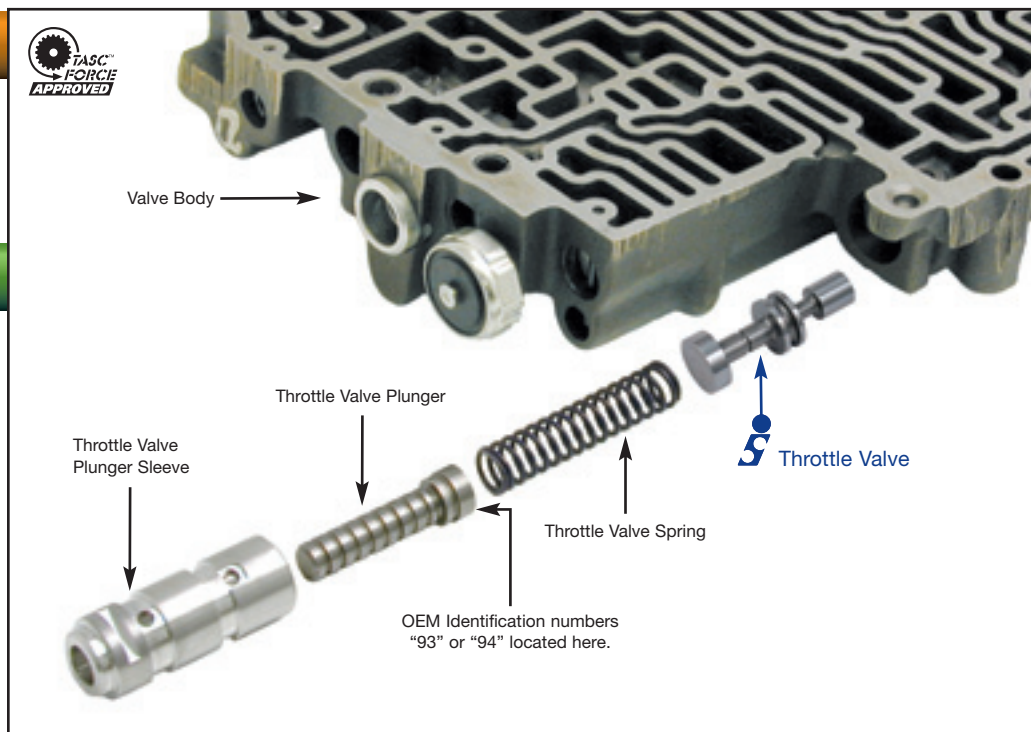
Lost, damaged or modified original valve

Many throttle valves have been modified or replaced with a kit version during previous rebuilds. This often alters performance, rendering the core unusable.

1 Throttle Valve

This direct replacement throttle valve aids in restoring the core to original condition by following the OEM design.

Modifying or replacing the throttle valve is a common practice during rebuild, but these modifications and replacements often alter performance, leaving the core unusable. The Sonnax replacement throttle valve aids in restoring the core to original condition by following the OEM design.

- Valve is made from hardened steel.
- Follows OEM design.
- Salvages cores.
