3-4 Accumulator Sleeve Kit

77998-01K

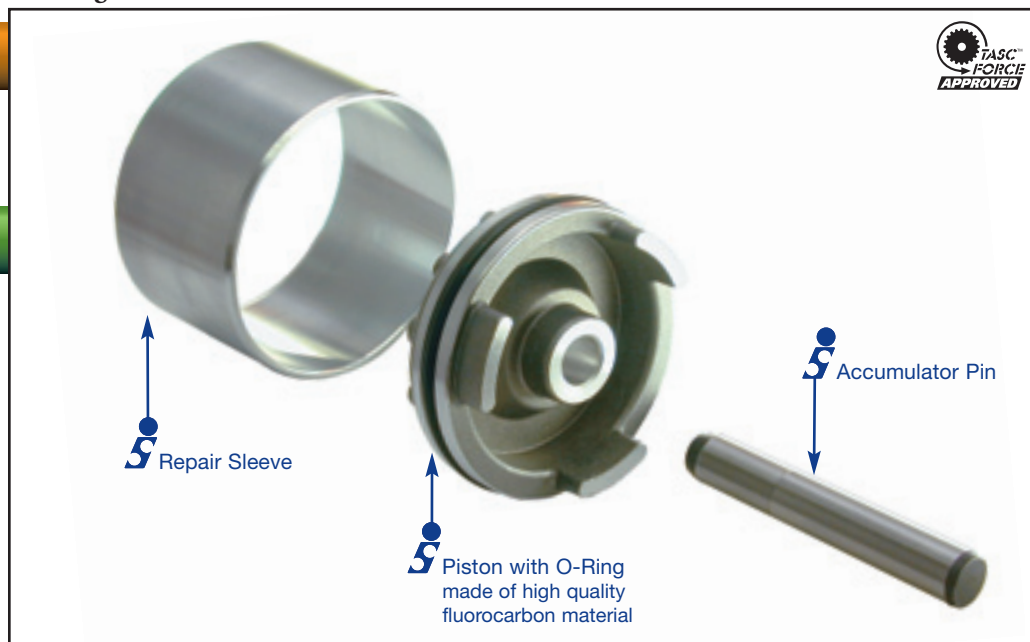
This simple drop-in solution comes with an aluminum sleeve, a replacement piston with an o-ring seal, and a new accumulator pin. It is compatible with all OEM accumulator springs.

The 3-4 accumulator bore on the 4L60 & E cases can become scored, resulting in the loss of 4th servo feed and 4th accumulator pressure. Scoring is caused by repeated oscillation of the accumulator piston within the bore during normal operation. Once this bore is damaged the case must be scrapped. Install the Sonnax Accumulator Sleeve Kit 77998-01K.

- Sleeve is manufactured from wear-resistant aluminum.
- Piston with o-ring seal is made of high-quality fluorocarbon material.
- Kit includes new accumulator pin.
- Piston is compatible with all OEM accumulator springs.
- Requires no machining of the transmission case.
