COMPLAINT

Code 741 / no lock-up

Oversized TCC Apply Valve Kit

84754-50K

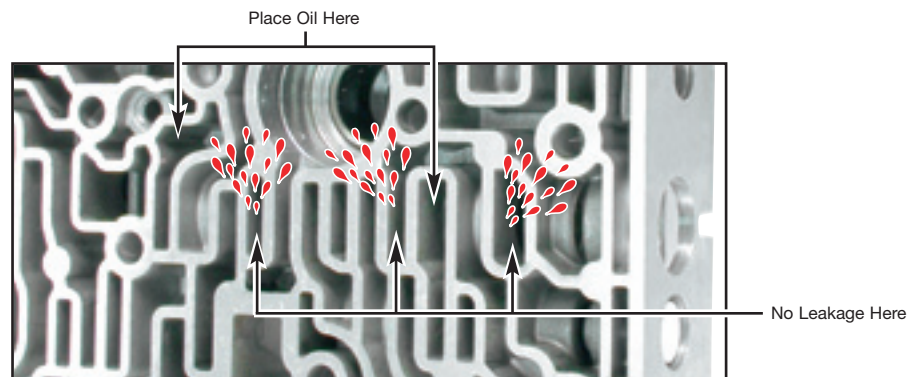
Continuous oscillation of the converter apply valve in the cast-aluminum bore causes bore wear that prevents the valve from stroking to the lock-up position.

You need 84754-50K if ... Wet Air Test fails inspection in locations shown.

Correct TCC concerns and salvage the valve body core by reaming the worn bore and installing Sonnax oversized TCC apply valve kit.
