Solenoid Modulator Valve Kit

27741-13K

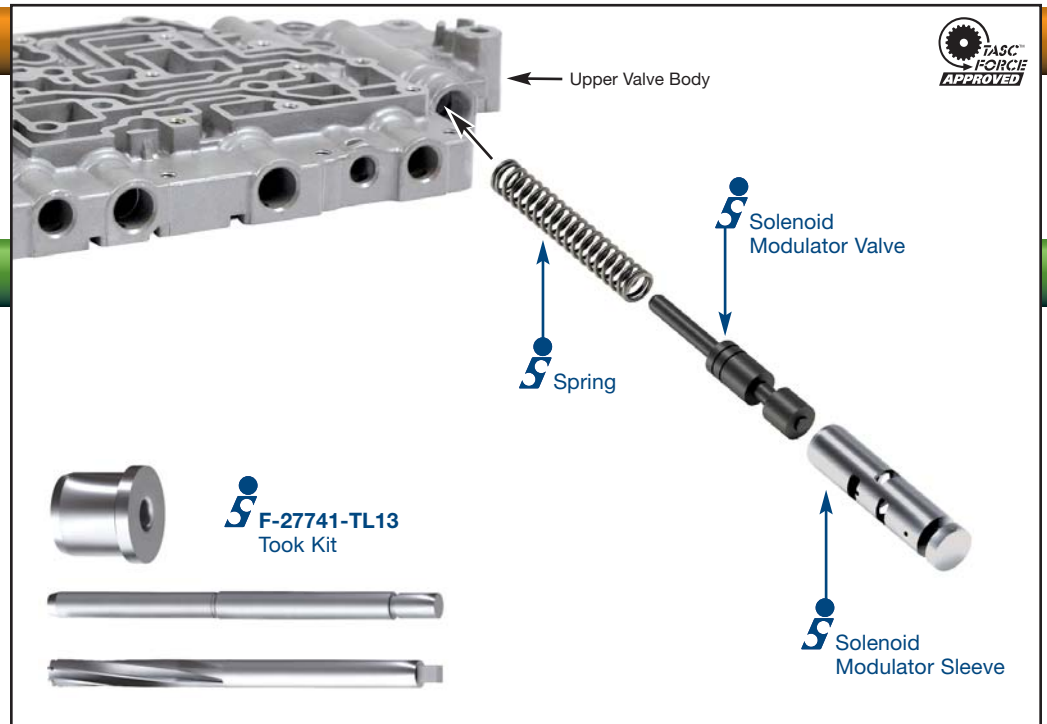
F-27741-TL13

Excessive solenoid pressure is caused by line pressure side-loading the steel solenoid modulator valve along with the continuous oscillation of the valve, which wears the cast aluminum bore.

The modified valve and high-grade aluminum sleeve allow the bore to be refurbished, and prevent side-loading of the valve and future wear.

- 1 Reamer
- 1 Reamer Jig
- 1 Guide Pin
