COMPLAINT

Boost Valve & Sleeve Kit

84754-30K

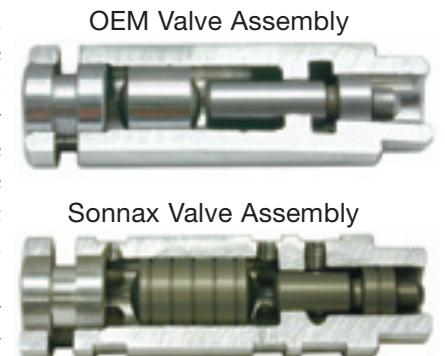
Bore wear near the small valve causes harsh or delayed reverse depending on the location and severity of the leak, and the temperature wear near the end plug causes soft shift quality and low line rise.

Vehicles with a 4T65-E transmission often exhibit such problems as soft upshifts (especially 1-2), delayed reverse and low line rise. This can be traced to wear of the OEM boost sleeve assembly. The OEM boost sleeve assembly consists of 2 steel valves and a steel plug that reside in the boost sleeve. The steel valves wear the aluminum sleeve and allow leakage of boost pressure. The OEM boost sleeve assembly is not serviceable separately from OEM, which forces the purchase of a new and expensive valve body. Sonnax now offers an upgraded boost sleeve assembly **84754-30K** to replace the worn OEM parts and allow the OEM valve body to be used and restore the hydraulic integrity of the circuit.

The replacement boost sleeve delivers oil 360° around the valve, reducing side load. Also the surface contact of the spools is greater, which improves durability and reduces oil loss.

- Valves are made of hard-anodized aluminum for better wear resistance.
- Valves are designed to increase oil lubricity, center the valves and increase longevity.
- Line boost valve is longer than the OEM valve to increase wear surface area.
- Sleeve is made of highly wear-resistant aluminum and has been designed with oil channels to evenly distribute boost valve oil.
- Kit is a drop-in replacement and requires no machining.
