42-47RH/RE, 48RE

PART NUMBER 22771A-01, 22771A-13, 22771A-TL13

4-Spooled Switch Valves

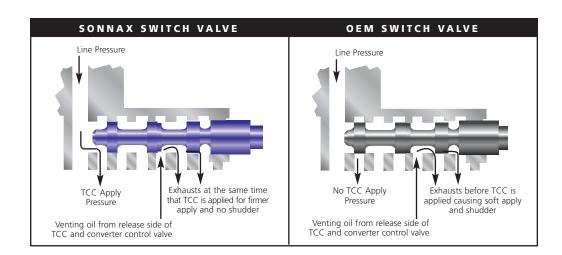
Bore wear toward the spring end reduces converter release oil. This affects converter charge at idle, causing engine stumble, loss of lube oil flow, overheating and poor performance. Bore wear at the inboard end creates poor TCC apply or a reduction in line pressure boost. Switch valve bores with excessive wear can now be repaired with Sonnax oversized switch valve 22771A-13. If the bore is not excessively worn, install Sonnax standard OEM-size switch valve kit 22771A-01. Both the oversized and standard size Sonnax valves will improve the timing and flow to the apply and release circuits.

- Valve controls TCC release oil venting during apply for a firmer apply and no shudder.
- Stem length, spool spacing and exhaust timing have been improved to ensure quicker stroke and less valve bounce.
- Salvages worn bores.
