COMPLAINT

Actuator Feed Limit Valve Kit

34200-16K

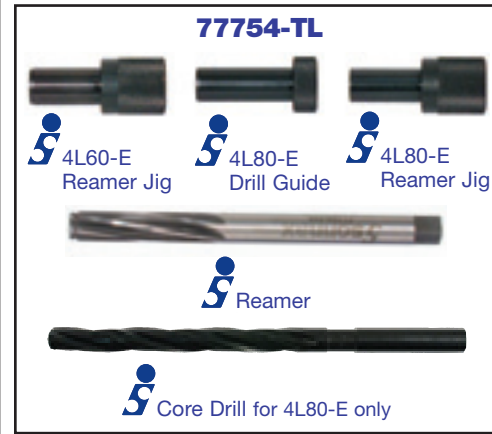
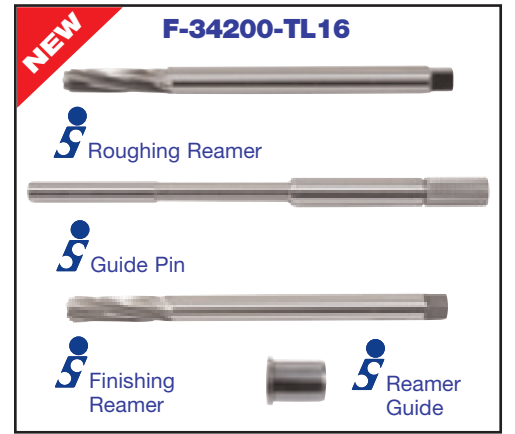
- 1 Valve Sleeve Assembly
- 2 Springs
- 1 Retaining Clip

- 1 Core Drill (4L80-E only)
- 1 Reamer
- 3 Guides (1 for 4L60-E, 2 for 4L80-E)
- 1 Drill Bit (.051")

- 1 Roughing Reamer
- 1 Finishing Reamer
- 1 Guide Pin
- 1 Reamer Guide
- 1 Drill Bit, .051"

The OEM actuator feed limit (AFL) valve has a large reaction area and is greatly affected by side loading, which wears the valve body bore. The EPC solenoid oscillates the torque signal and AFL oil, which increases valve action. As bore wear increases, oil pressure is reduced to the shift solenoids, which causes solenoid and ratio codes. The same AFL oil loss results in lower line pressure.

- Kit includes wear-resistant sleeve and anodized valve with annular grooves to prevent side loading.
- Valve operates in full-contact sleeve, providing 54% more support.
- Boosts oil pressure to the shift solenoids.
- Eliminates AFL oil loss, corrects low line pressure.
- Kit can now be installed using bench style reamer kit 77754-TL or F-3400-TL16 tool kit and the valve body fixture **VB-FIX**.
