Chrysler 845RE; ZF8HP45, ZF8HP70

Zip Kit®
ZF8-ZIP

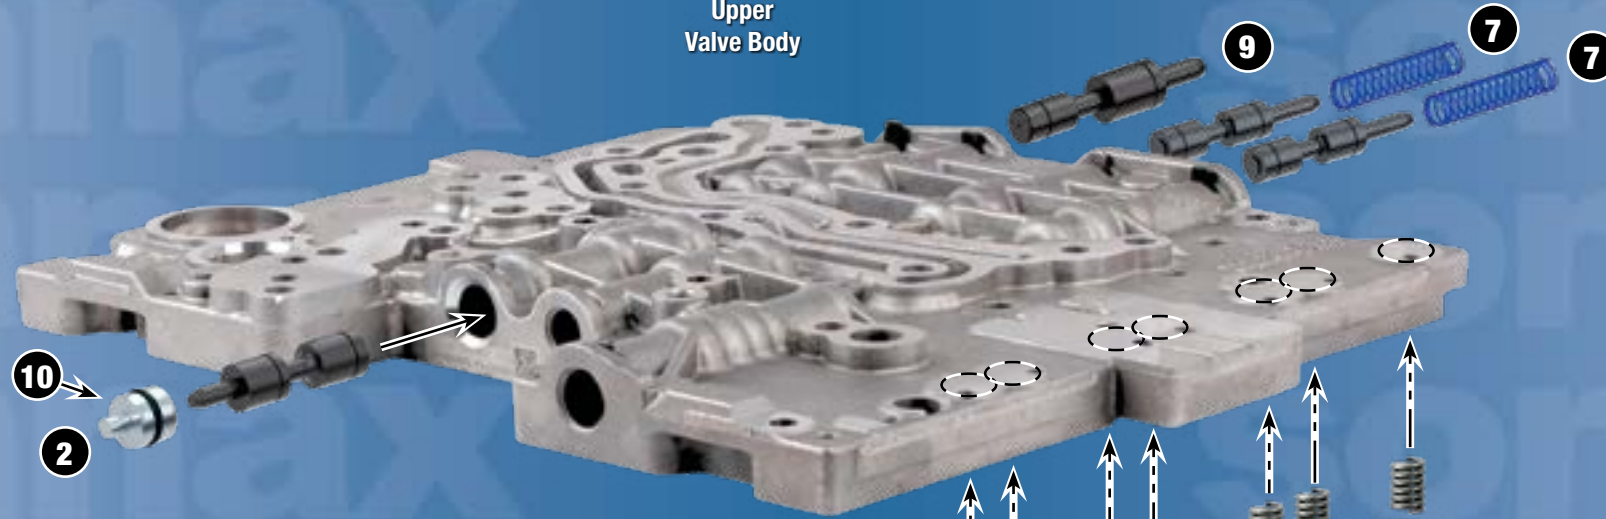
ZF8HP45
Upper
Valve Body

1 35740-13K Oversized TCC Valve Kit

2 35740-18K Oversized TC Pressure Valve Kit

3 35740-05 Oversized TC Switch Valve

4 35740-03 Pressure Regulator Sleeve

5 35740-01K Oversized Pressure Regulator Valve Kit

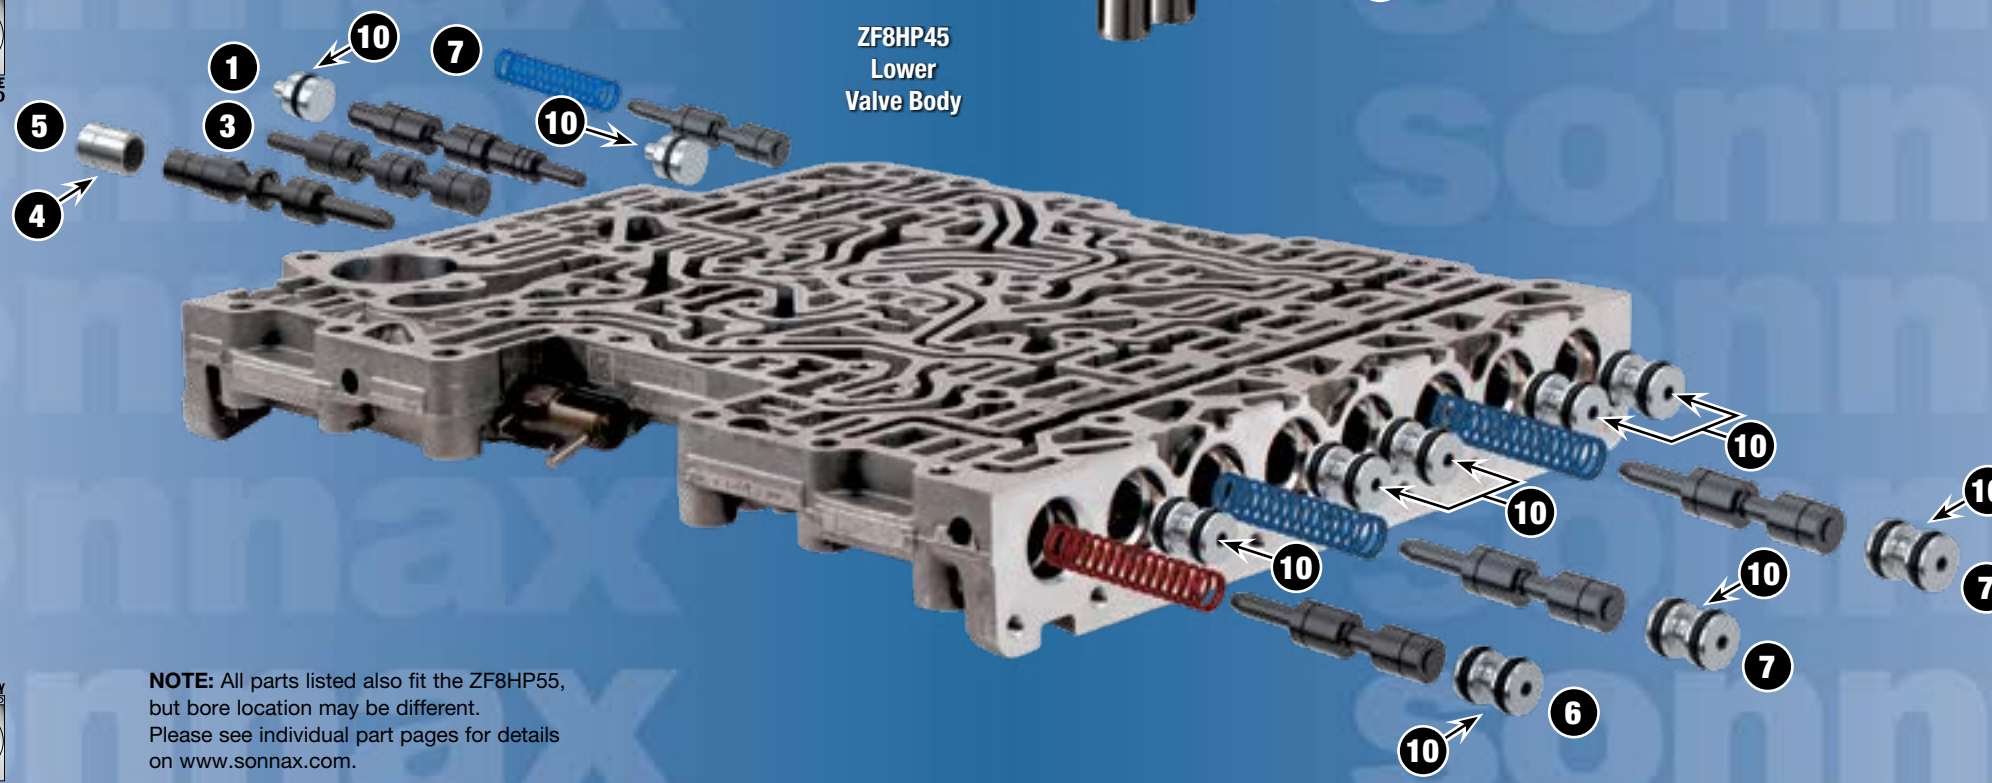
ZF8HP45
Lower
Valve Body

6 35740-21K Oversized Priming Valve Kit

7 35740-20K Oversized Clutch Holding Valve Kit

8 95740-15K Accumulator Piston Kit

9 35740-22 Oversized B2 Clutch NIC Valve

10 35740-30K O-Ringed End Plug Kit

NOTE: All parts listed also fit the ZF8HP55, but bore location may be different. Please see individual part pages for details on www.sonnax.com.
