Intermediate Servo Piston & Sleeve Kit

35709-01K

Sonnax Part Summary

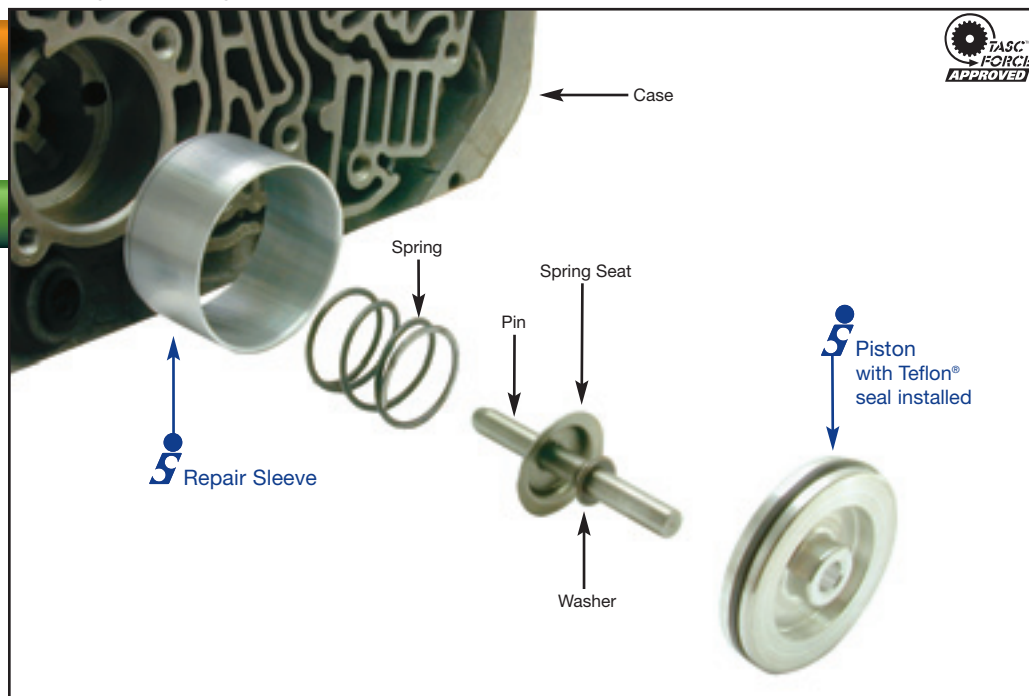
Case bore wear and oil loss at the intermediate servo.

The intermediate servo bore becomes scored from repeated cycling. The spring side of the piston has line pressure present in R, N, D. Excess leakage at the servo piston results in low line pressure and delayed engagements. During forward speeds, oil loss affects shift quality and reduces clutch life. To salvage cases install Sonnax Intermediate Servo Sleeve Kit **35709-01K**.

This drop-in sleeve and piston salvages the case, and eliminates the complaints caused by oil loss.

- Kit contains an aluminum sleeve and a replacement piston with a Teflon® seal.
- This kit is a simple drop-in solution and requires no machining of the transmission case.
