Cooler Bypass Valve Kit

36605-02K

Sonnax Part Summary

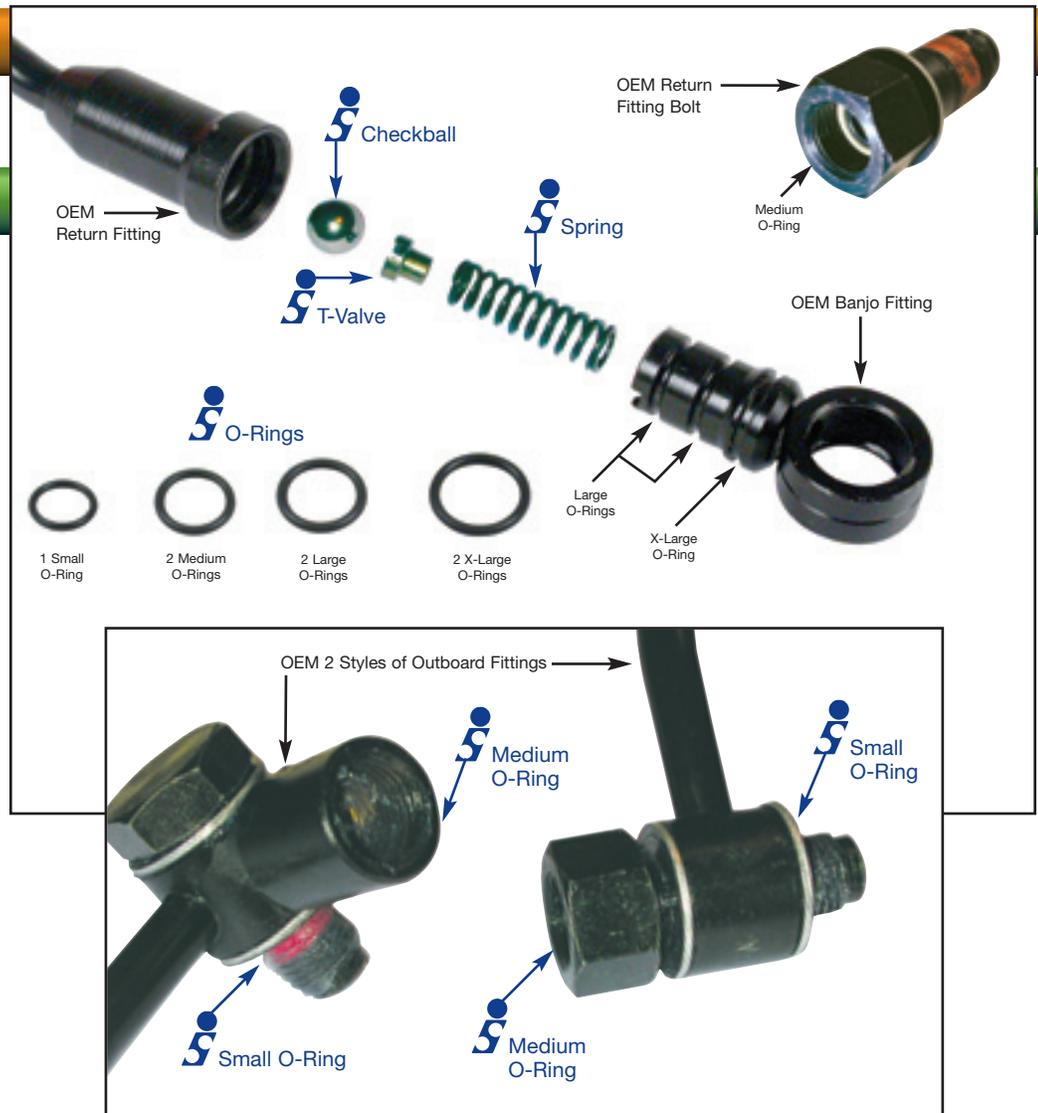
- 1 T-Valve
- 1 Spring
- 1 Checkball
- 1 Small O-Ring
- 2 Medium O-Rings
- 2 Large O-Rings
- 2 Extra Large O-Rings
- 1 Extra

The Sonnax cooler bypass kit salvages the OEM fittings and tube, and maintains cracking pressure at 70-75 psi.

Sticking of bypass components, spring relaxation or poor ball seat will allow the bypass to open at lower cracking pressure. This reduces TCC apply pressure, cooler flow at the overdrive section, and radiator flow responsible for heat transfer. The Sonnax kit allows the bypass valve assembly to be rebuilt and maintains cracking pressure at 70-75 psi.

- Hardened steel T-valve provides secure checkball seat and adequate bypass flow.
- New spring cracks open at 70-75 psi to provide lube if cooler is blocked or restricted.
- Hardened alloy steel checkball resists damage.
- Seven new o-rings provide positive seal for cooler circuit.
- Allows salvage of the OEM fittings.
