COMPLAINT

Low line pressure and TCC concerns

Pressure Regulator Valve Kit

36940-03K

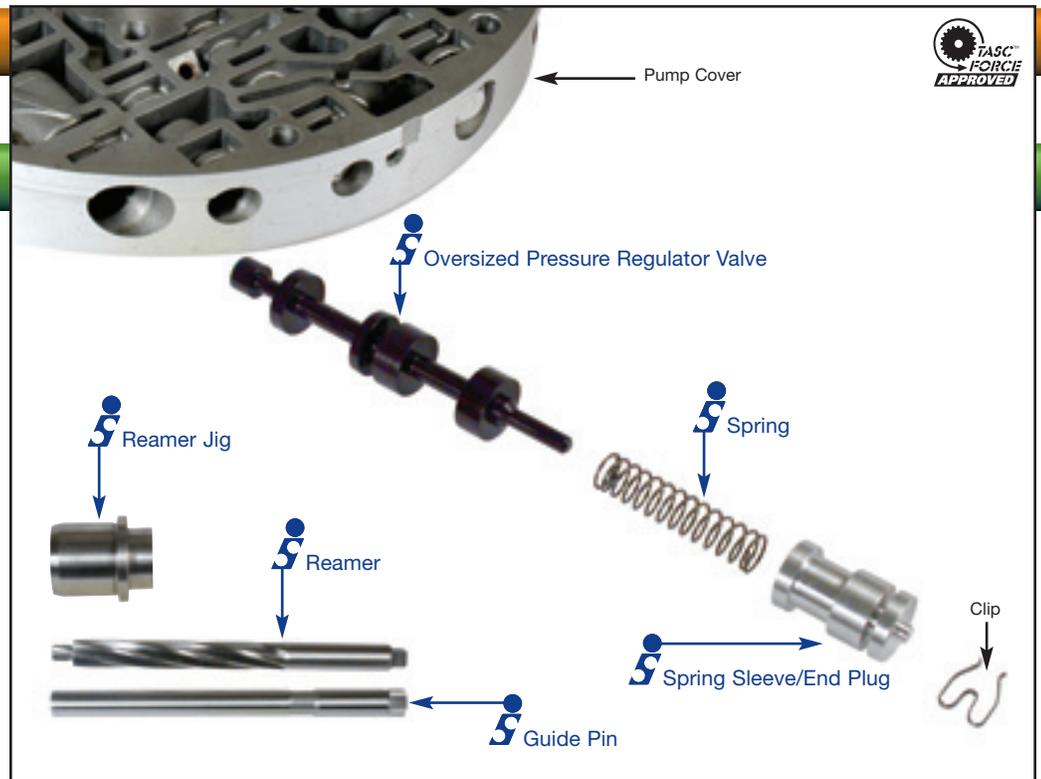
Note: A specially designed oversized base plate **VB-06** must be mounted to the **VB-FIX** to accommodate the 5R110W pump body.

Oversize the bore with the Sonnax tool kit and install the Sonnax oversized pressure regulator valve kit with spring sleeve and custom spring.

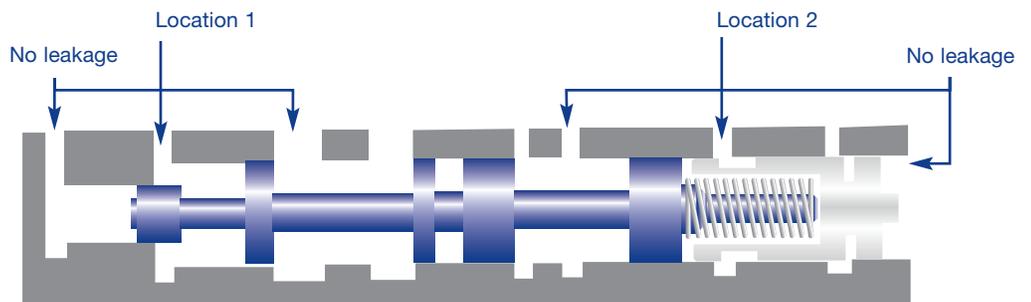
A Wet Air Test at the balance end circuit and at the LPC/PCA solenoid circuit at the locations indicated results in leakage at the neighboring ports, or if a vacuum test at these two locations gives less than 18" of vacuum.
