36950-01

1 Heavy Gauge Oil Pan

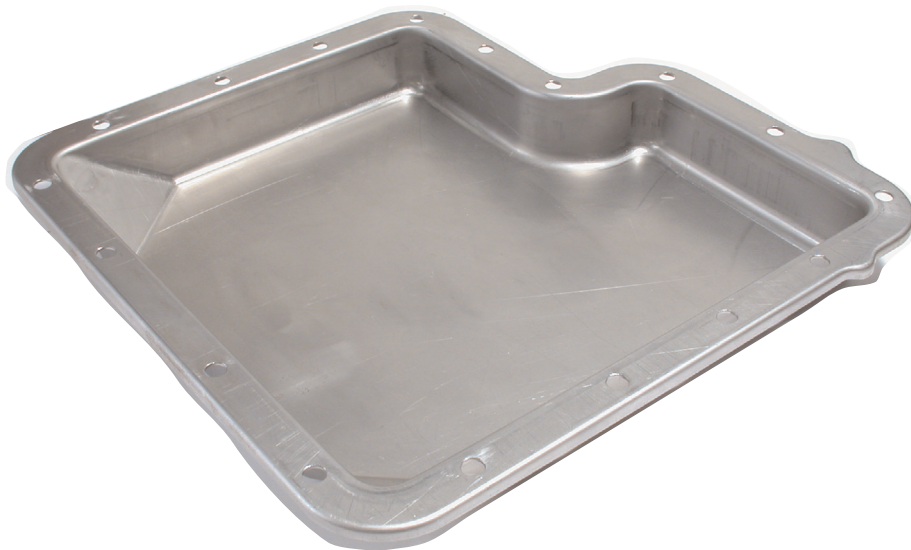
Ford vehicles with C6 transmissions often have oil pan leaks. The original Ford C6 oil pans are made with thin-gauge steel. If the oil pan bolts are over-tightened, the flange at the bolt holes will warp and will result in a poor gasket seal. Once the oil pan flange is distorted, it is difficult to repair the pan flange to get a good seal. The Sonnax C6 oil pan **36950-01** is made of thick gauge material and will resist warping at the bolt holes. The thicker flange will allow the bolts to be tightened enough to compress the gasket evenly and result in a good seal. The Sonnax pan will withstand repeated assembly without damage.
