Lockup Control Plunger Valve & Sleeve Kit

57917E-03K

Note: Fits applications U140E/F, U151E/F, U240/241E & U250E.

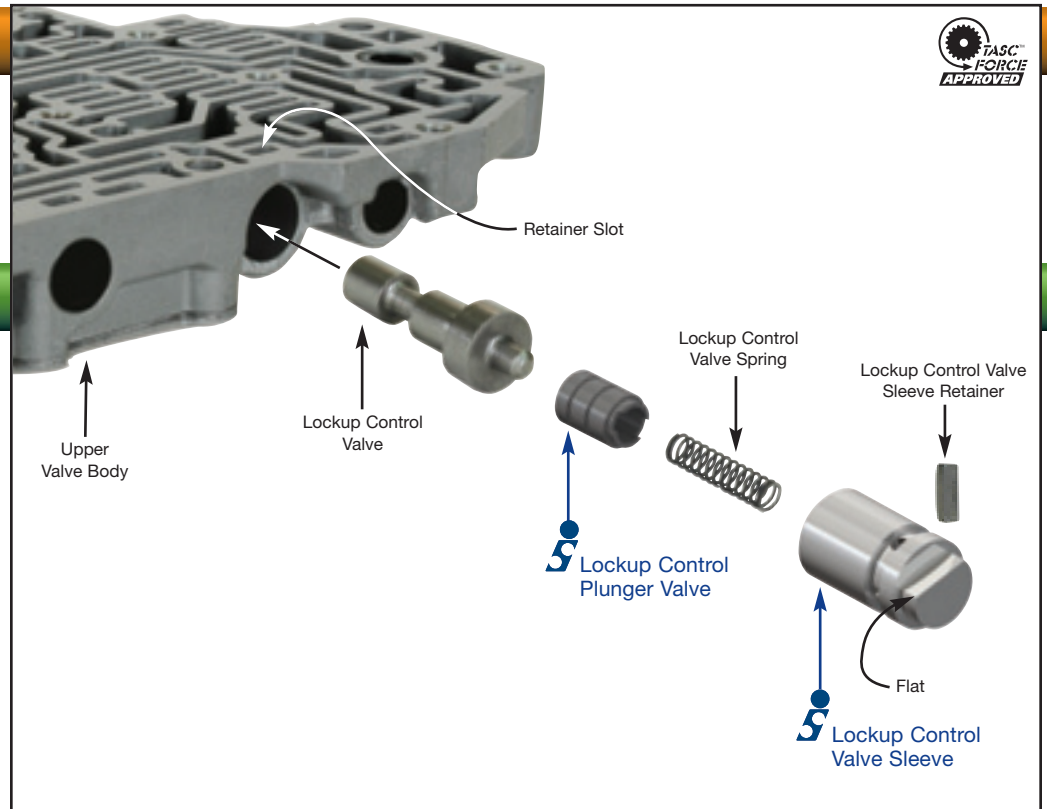
- 1 Lockup Control Plunger Valve
- 1 Lockup Control Sleeve

- The Sonnax sleeve is manufactured from highly wear-resistant billet aluminum.
- The Sonnax valve has been manufactured from hard-coat anodized aluminum to prevent wear.
- Annular grooves have been added to the valve to prevent sideloading-related wear.

Continuous oscillation of the steel lockup control plunger valve wears the cast-aluminum sleeve bore, allowing converter apply pressure to exhaust and preventing proper control of the lockup control valve.

The tightly tolerated, drop-in replacement Sonnax valve and sleeve assembly restores proper hydraulic clearances and uses upgraded materials to prevent wear.
