COMPLAINT

**3-4 Relay
O-Ringed
End Plug Kit**

77964-08K

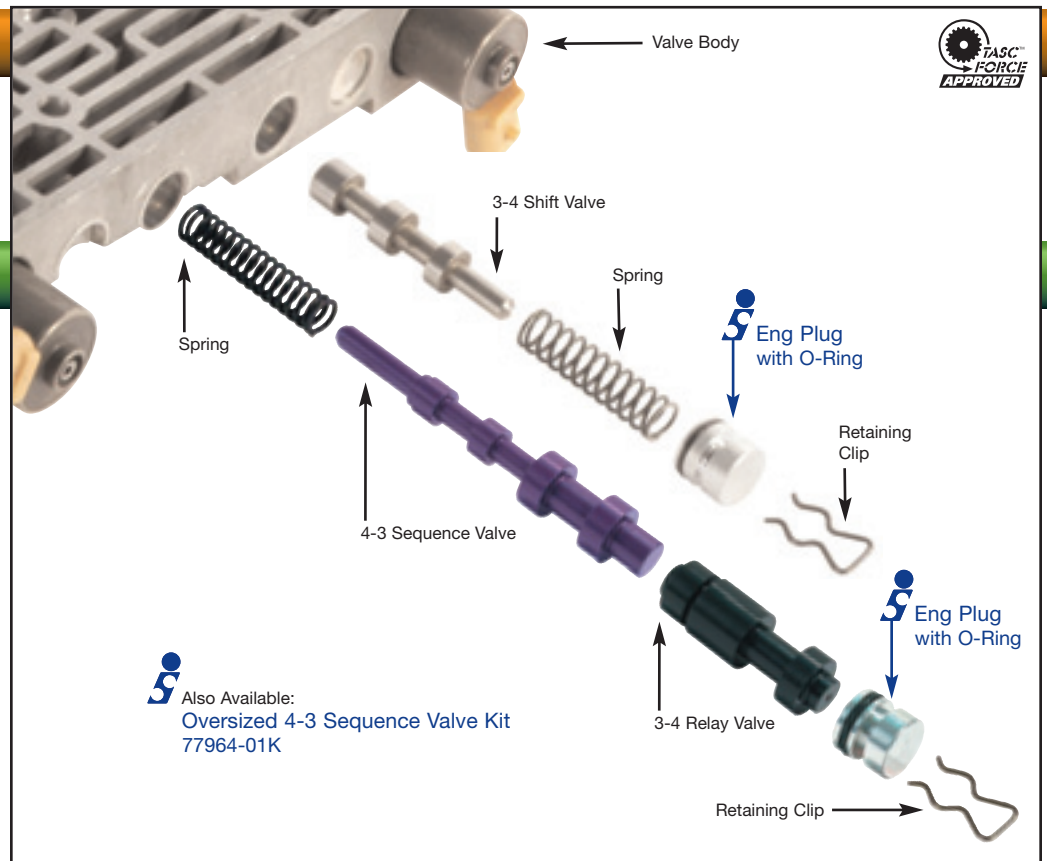
No 4th gear, drops out of 4th gear

- Loss of D3 oil • Loss of 4th signal oil

The hammering affect of the 3-4 relay and/or 3-4 shift valves can cause the soft aluminum end plugs to wear, resulting in loss of 4th signal and/or D3 oil.

Replace the worn OEM end plugs with the o-ringed Sonnax end plugs to prevent loss of critical 4th signal and/or D3 oil.

The hammering effect of the 3-4 relay and/or 3-4 shift valves can cause the end plugs to wear, resulting in loss of 4th signal and/or D3 oil. Replace the worn OEM end plugs with the o-ringed Sonnax end plugs to restore hydraulic integrity and prevent loss of critical 4th signal and/or D3 oil.

- O-rings on the end plugs provide a positive seal.
- Restores hydraulic integrity at the end plug.
