Chrysler 42-46-47-48RH/RE

sonnax®

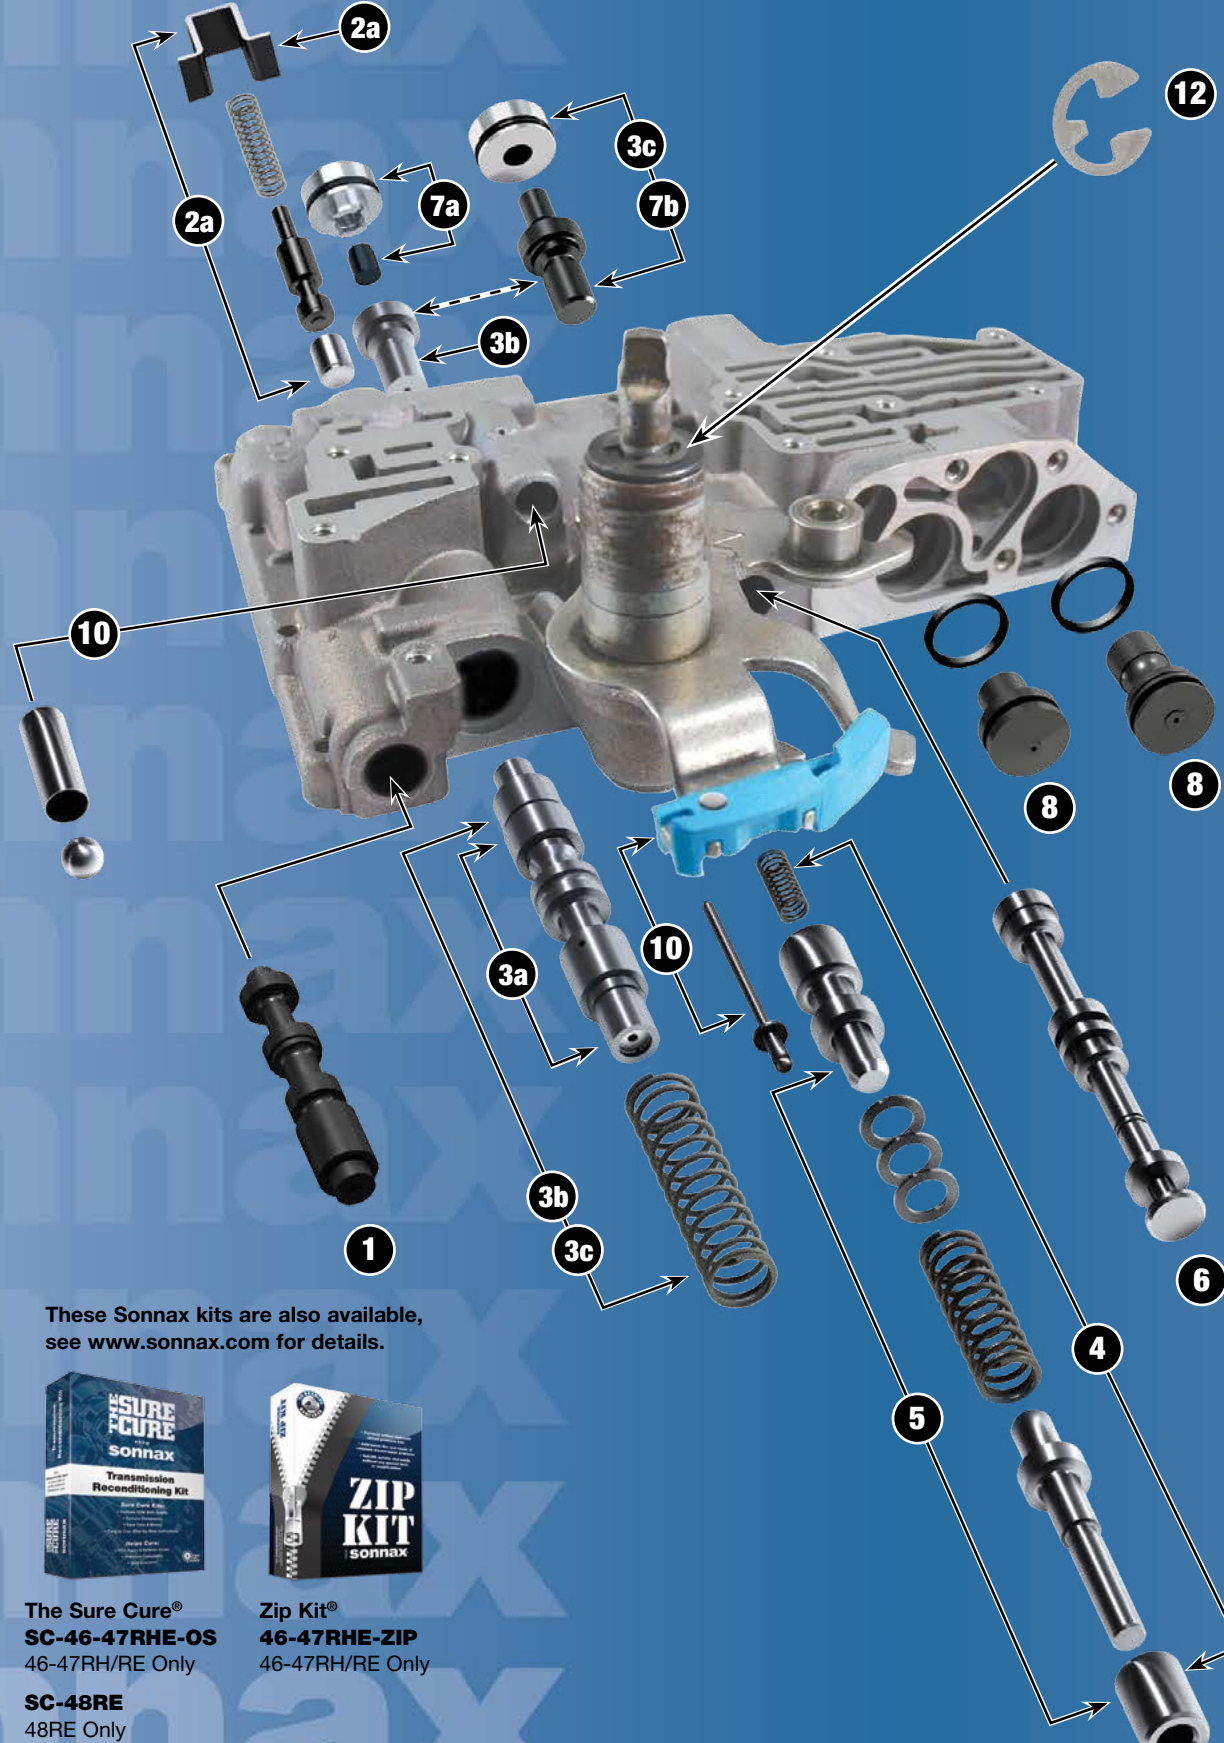
- 1 22771A-01**
4-Spool Switch Valve
22771A-13
Oversized 4-Spool Switch Valve

- 2a 22771-19K**
Oversized Lockup
Boost Valve Kit

- 3a 22771A-02K**
Lube Regulated Pressure
Regulator Valve

- 3c 22771A-16K**
Oversized Pressure
Regulator Valve Kit

- 4 22771-03K** .200" Plug Dia.
Throttle Valve Kit

- 5 22771-04K** .264" Plug Dia.
Oversized Throttle
Valve Kit

- 6 22771-09**
Manual Valve

- 8 22771-14K**
Governor Bore Plug Kit

- 9 22771-12K**
Valve Body Detent Ball
& Sleeve Kit

- 11 12861-01**
3-4 Accumulator Spring
